Phase 1 Geotechnical & Geo-environmental Site Investigation

Tilstock Road, Tilstock

Boningale Homes Limited

48888-ECE-XX-XX-RP-C-0003

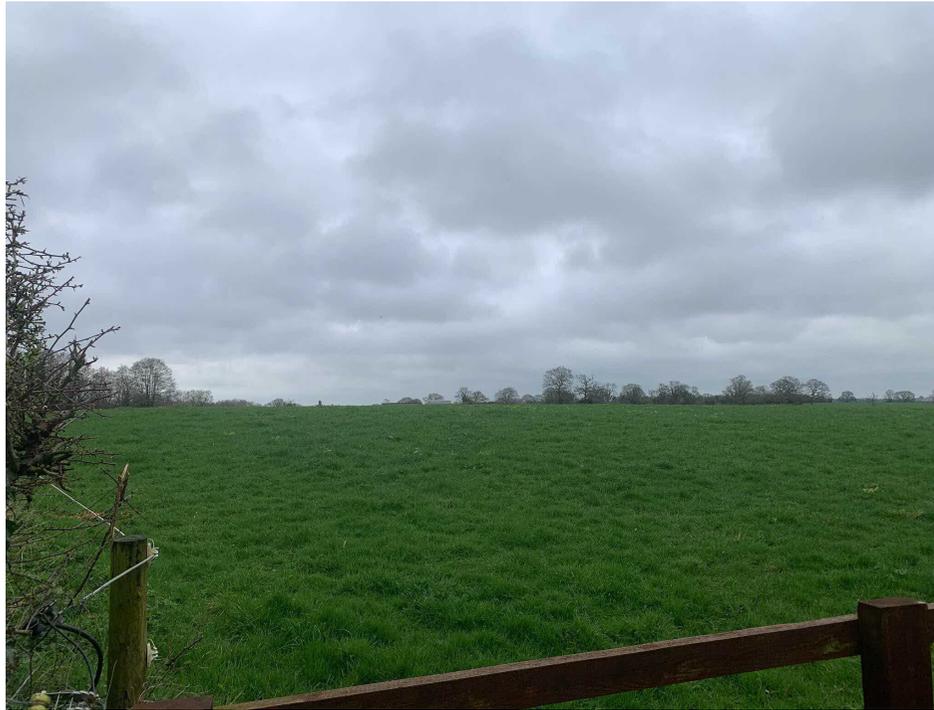
View of the south west of the site, facing north east.

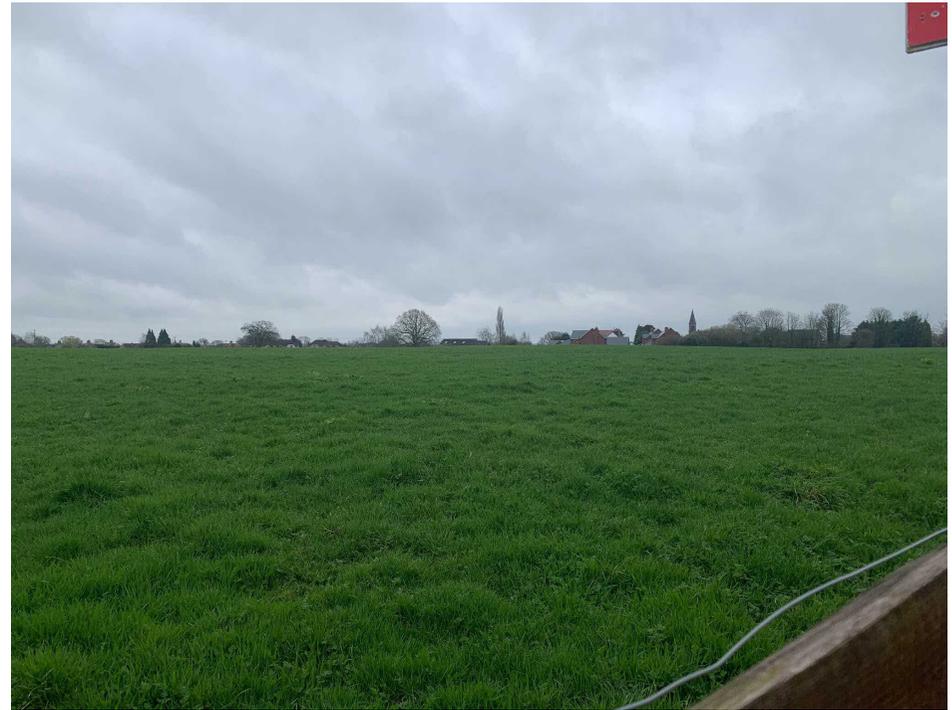
View of the north west of the site, facing south east.

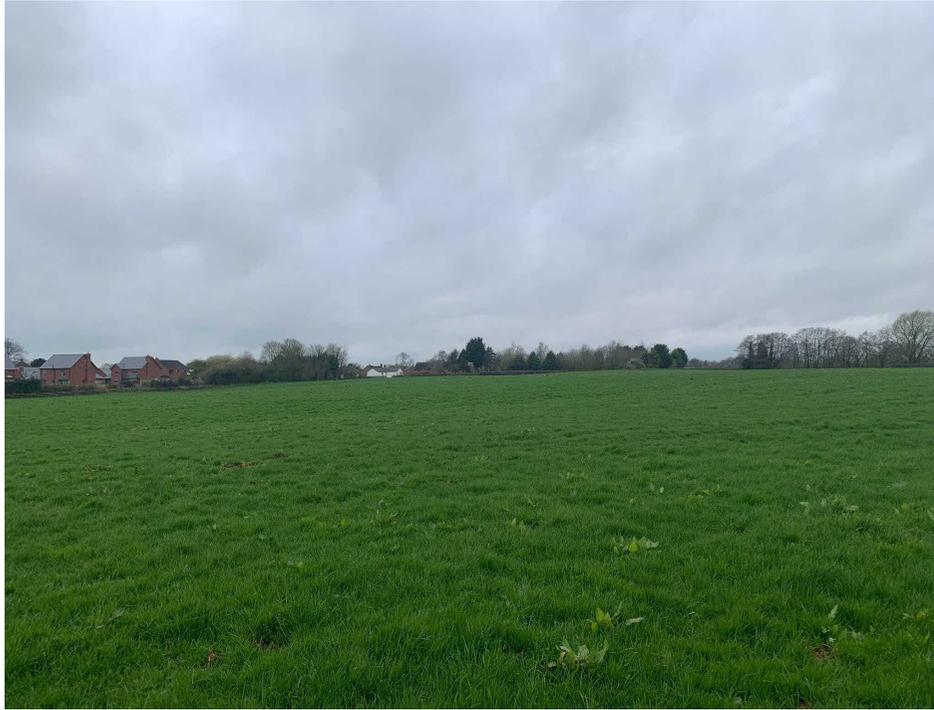
View of the north east corner of the site, facing south west.

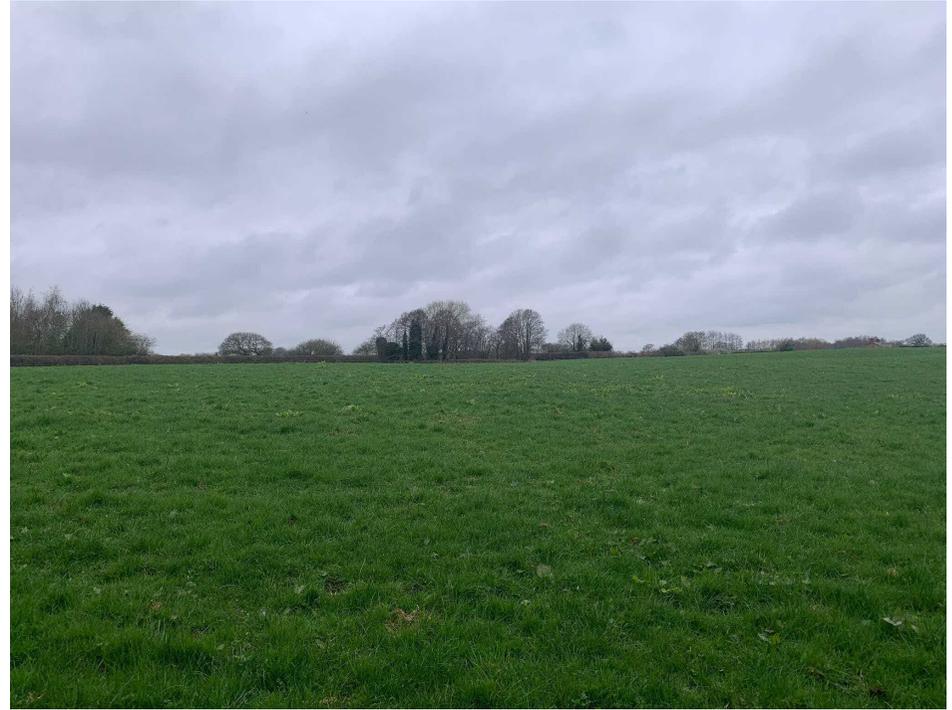
View of the south east corner of the site, facing north west.

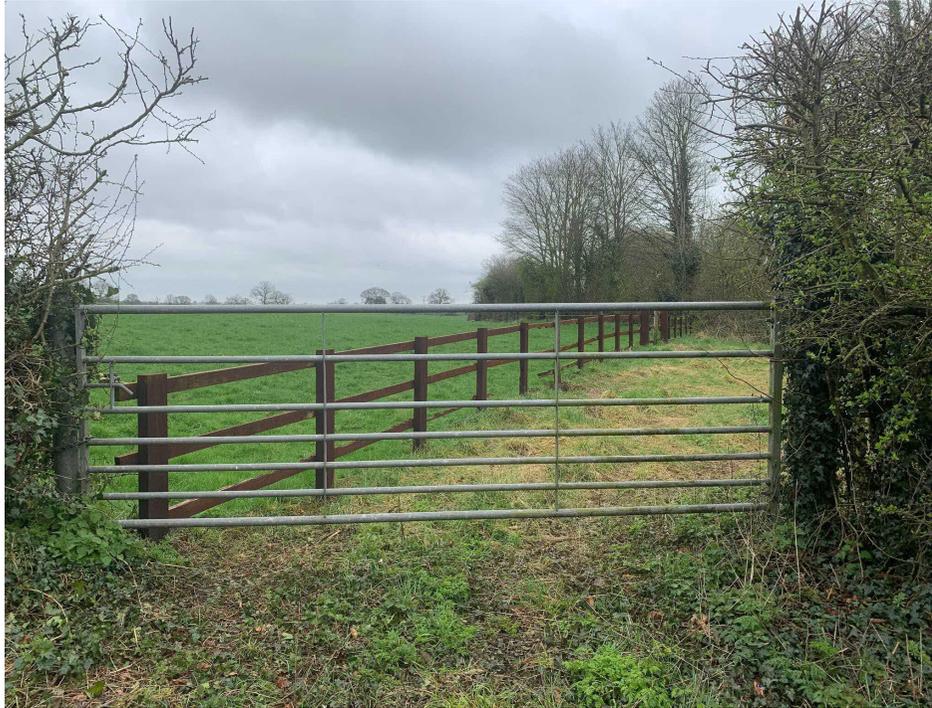
View of the entrance off Tilstock Road in the south west of the site, facing east.

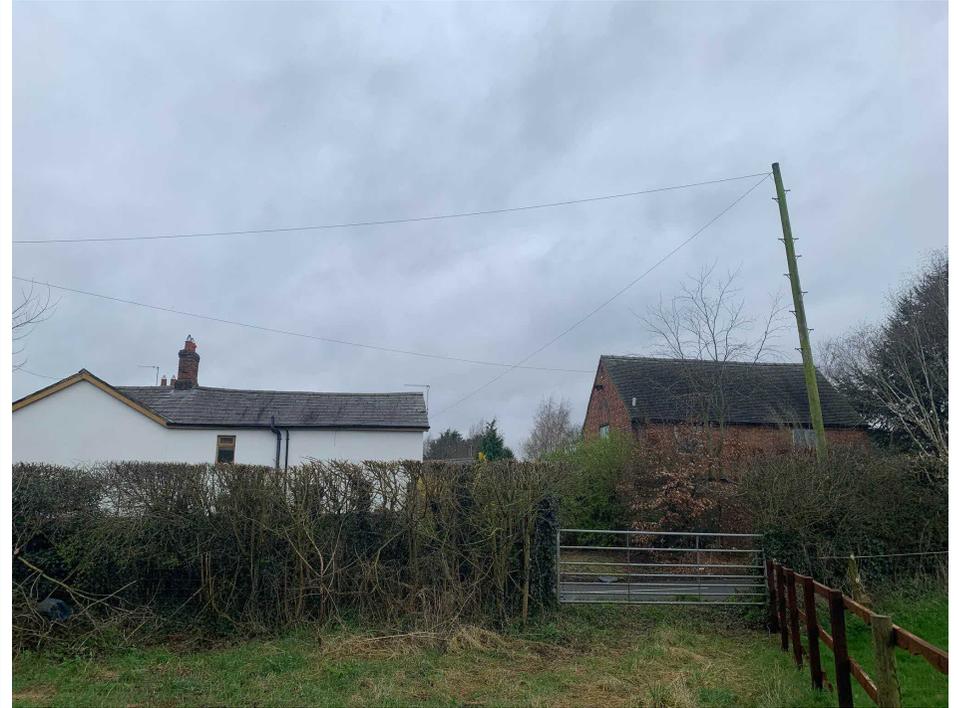
View of the entrance off Tilstock Road and telephone wire over the entrance of the south west of the site, facing west.

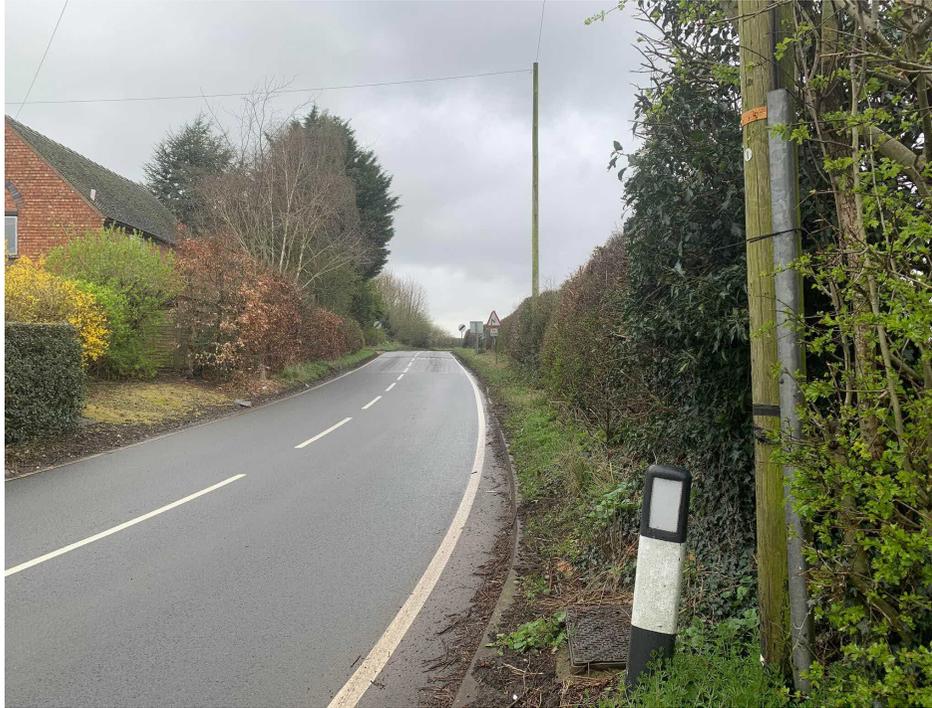
View of Tilstock Road to the south west of the site along the western boundary, facing north.

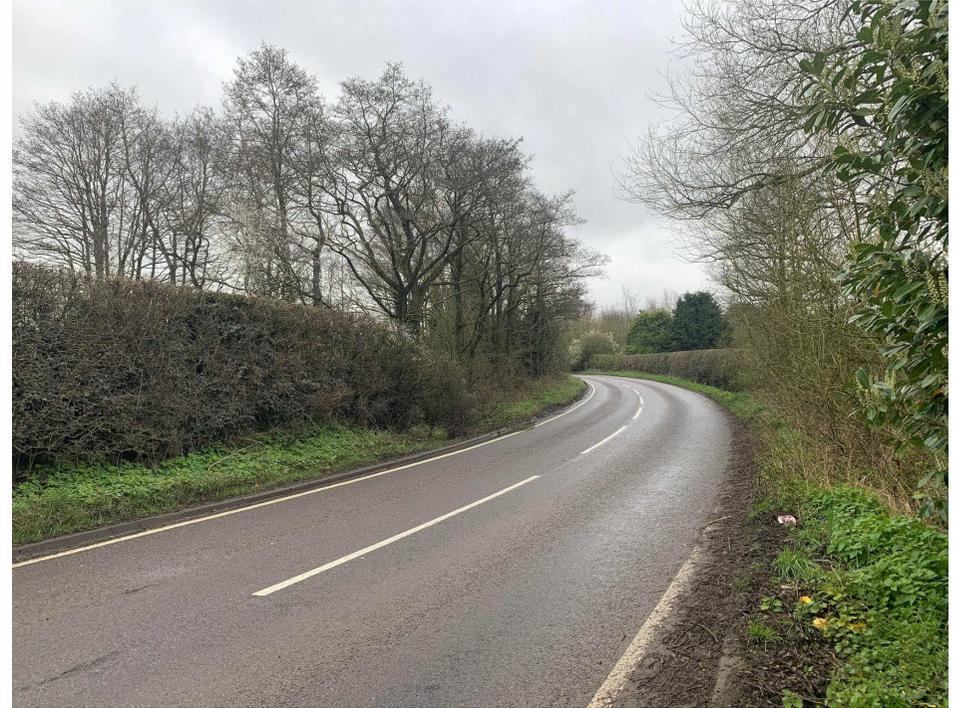
View of Tilstock Road to the north west of the site along the western boundary, facing south.

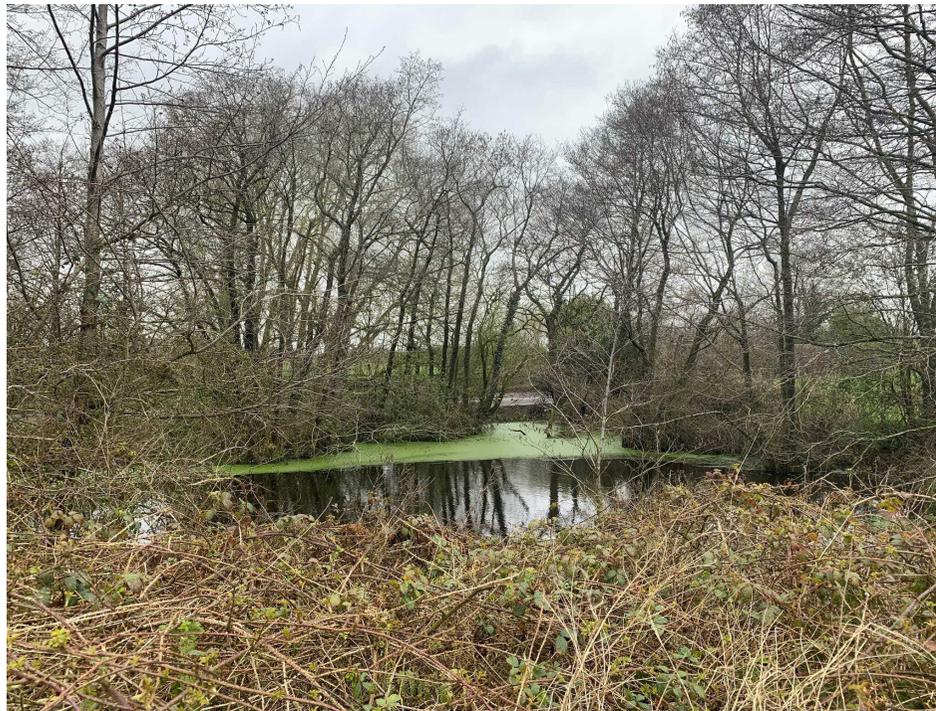
View of the pond to the north west of the site, adjacent to Tilstock Road, facing west.

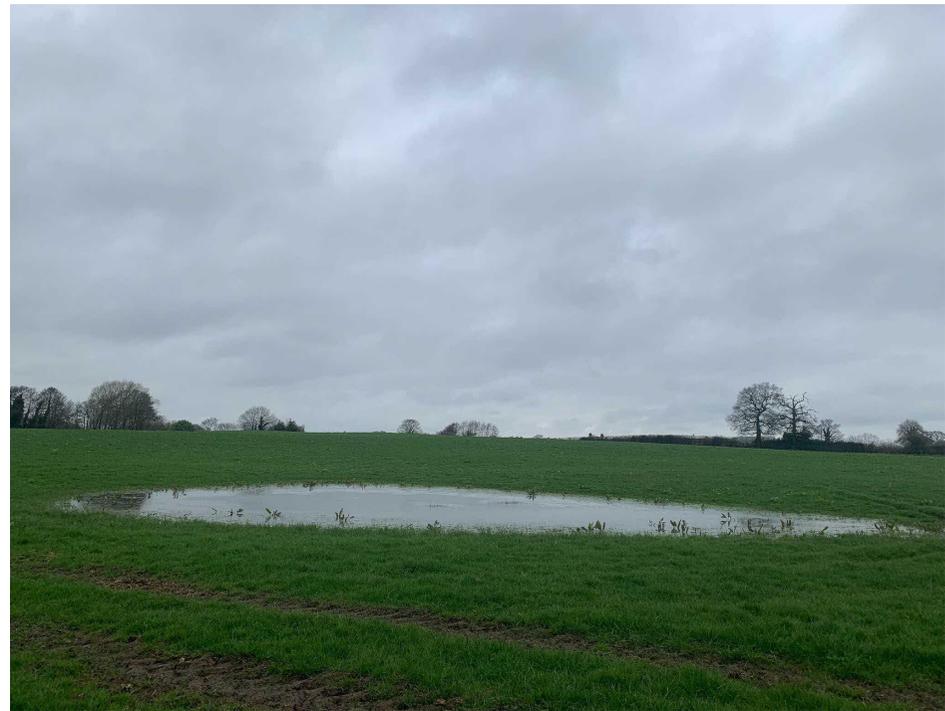
A small area (<5%) to the south east of the site is at low risk (1000-year return) of flooding from surface water.

View of the surface water flooding in the south east of the site, facing north west.

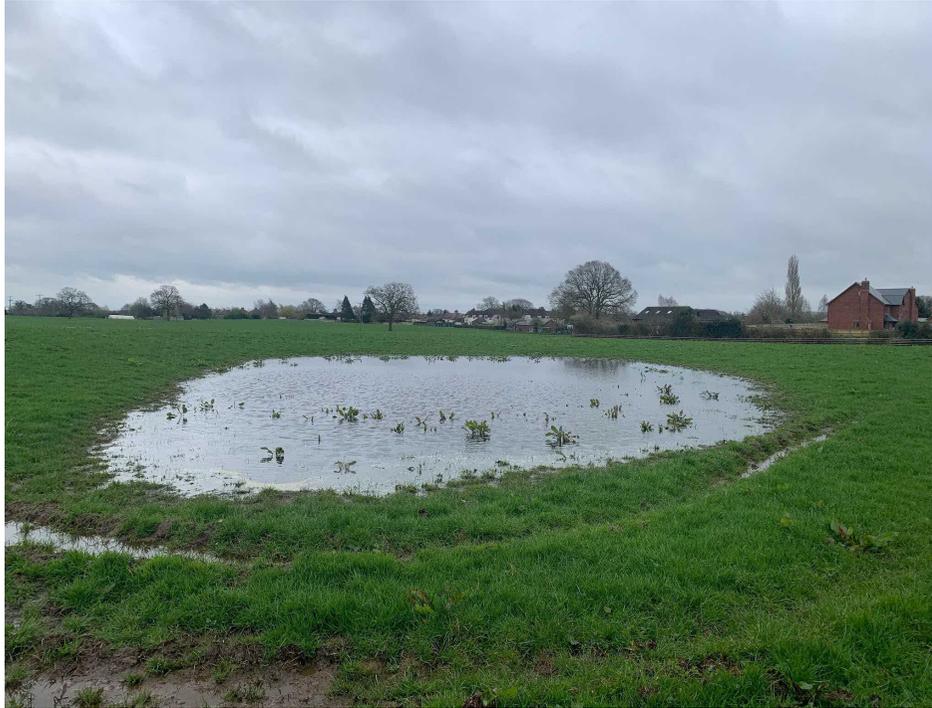
View of surface water flooding in the central area of the site, facing south east.

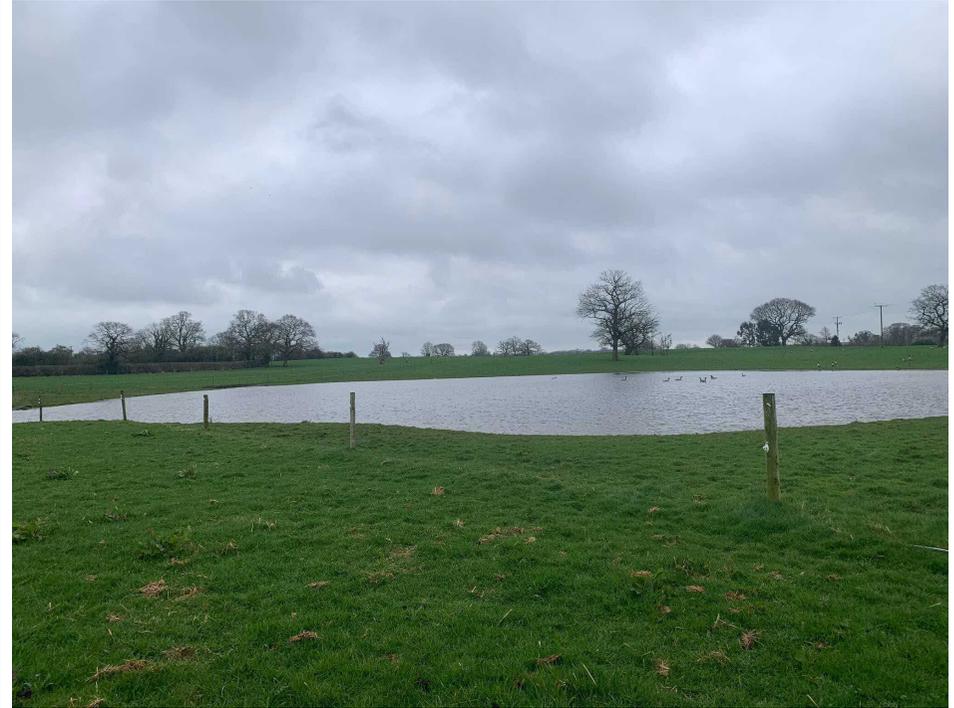
View of the surface water flooding to the east of the site, facing north east.

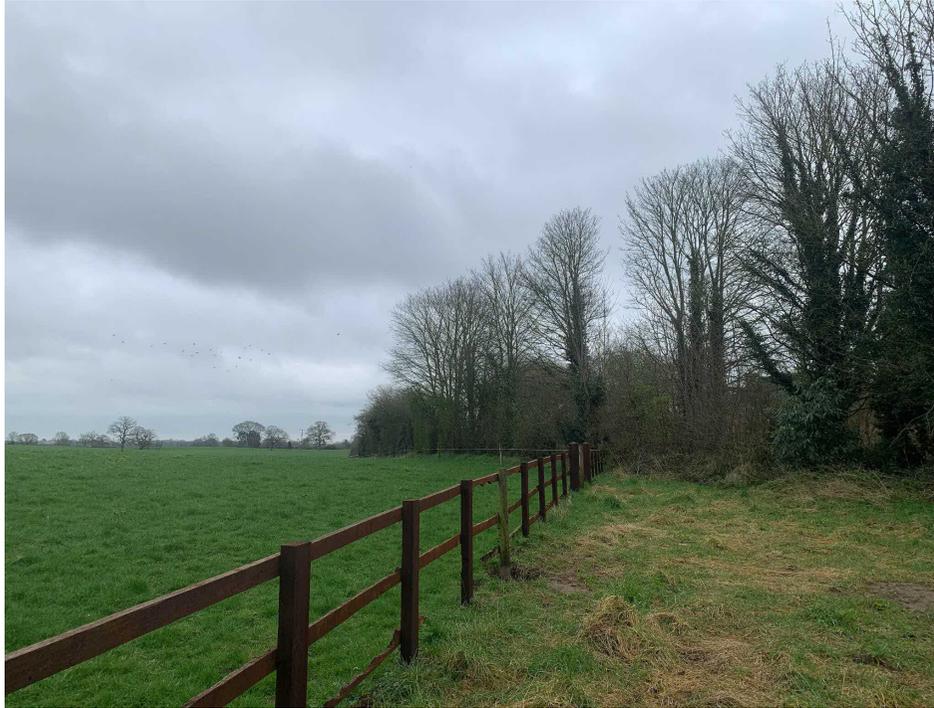
View of the southern boundary, facing east.

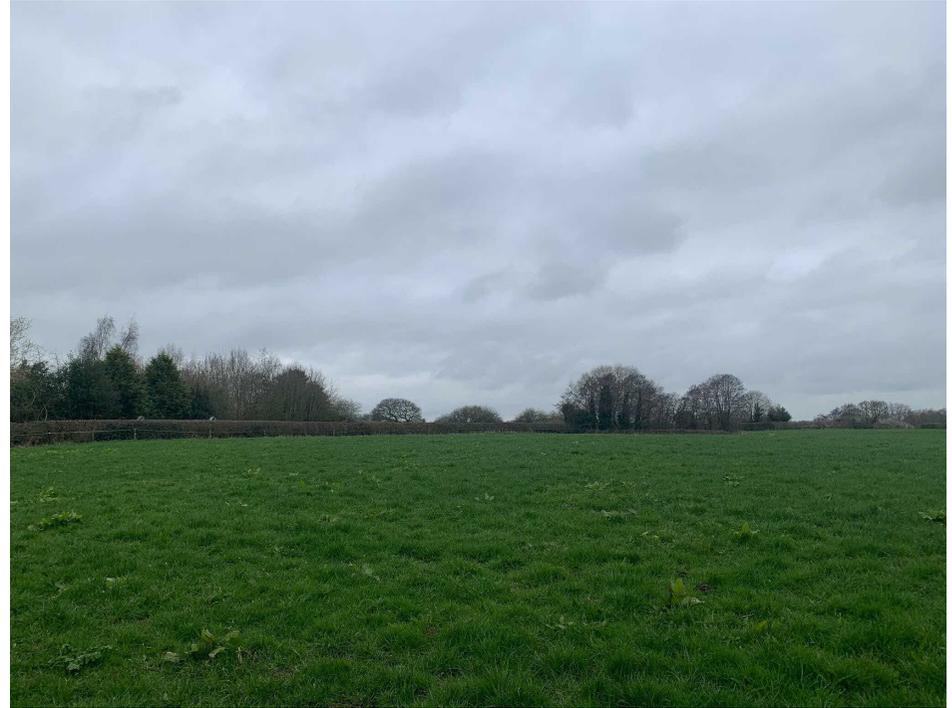
View of the western boundary, facing north west.
