## PROPOSED RESIDENTIAL DEVELOPMENT ACCESS TILSTOCK ROAD, TILSTOCK

STAGE 1 – ROAD SAFETY AUDIT

REPORT REF: 25-1858-RSA1

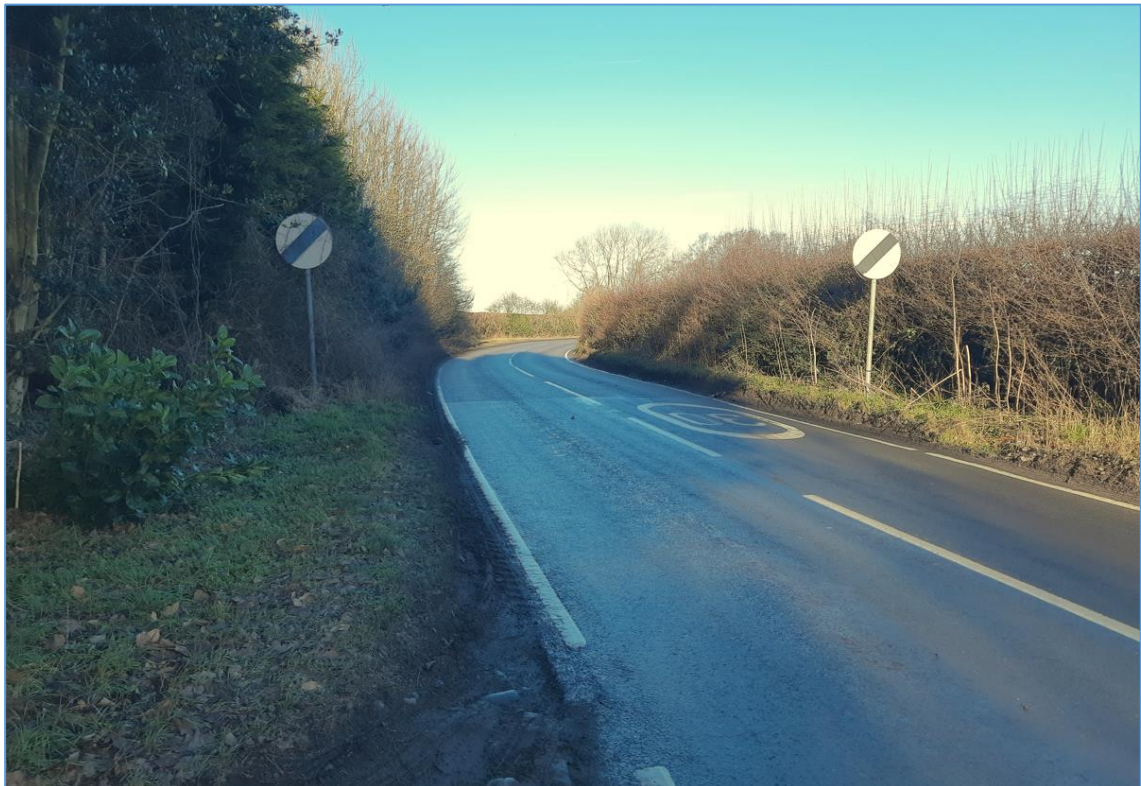
Location: Tilstock Road – southbound approach to the proposed site access.

Summary: Lack of awareness of the site access risks junction pull-out collisions.

Whilst the proposals include site clearance to provide visibility splays, based on recorded vehicle speeds, the location of the site access and presence of the national speed limit risk a lack of awareness for southbound drivers that the access will be located as shown. This could lead to a lack of awareness and late braking / shunts with emerging vehicles.

Recommendation:

It is recommended that, as part of the detailed design, the 30mph speed limit is extended to the north, alongside the relocation of the village gateway signing, to encourage greater awareness that drivers are entering a residential area alongside lower speeds.

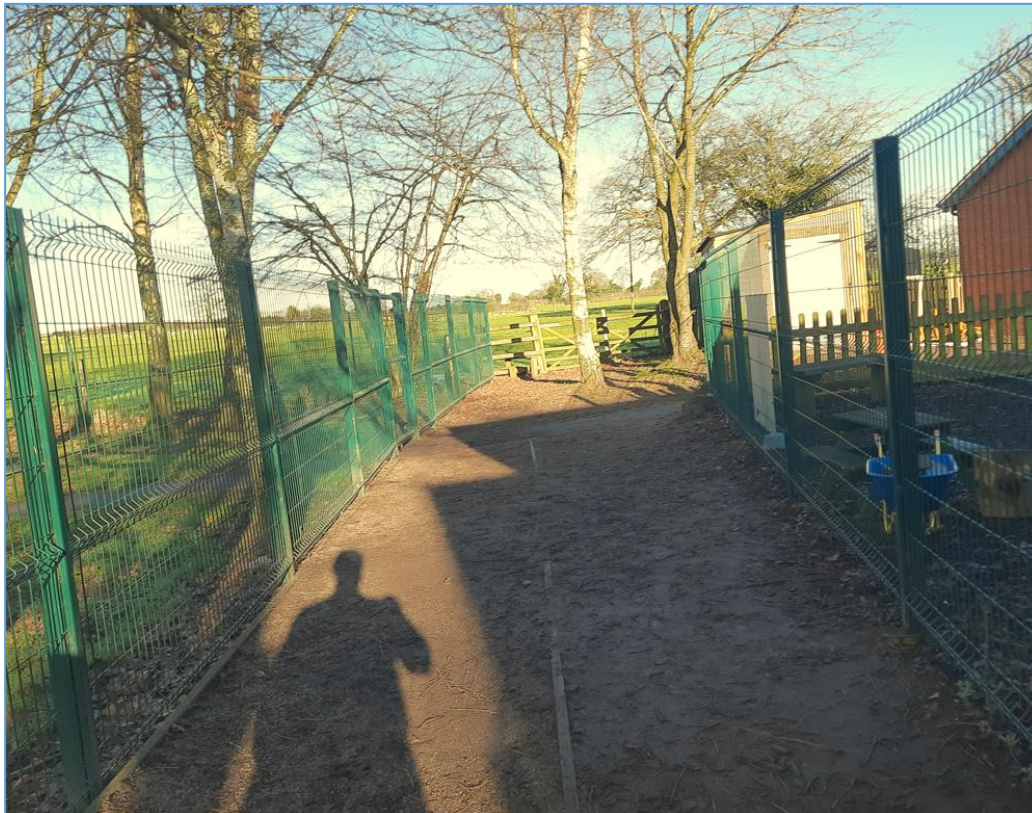
Location: Proposed pedestrian route – between the site and Tilstock Lane.

Summary: Unattractive pedestrian route risks pushing pedestrians to walk on Tilstock Road, risking vehicle to pedestrian collisions.

It is understood that a new 2.5m wide pedestrian route is to be provided between the site and the existing PROW 0233/28/1 that runs alongside (and provides pedestrian access to) the adjacent Primary School. Whilst the new provision is to be made using a bound surface and is to be lit, it is unclear whether the same will be the case for the existing PROW link which currently has a rolled stone surface and is unlit. Should this link be unattractive to pedestrians – both from a usability based on surface type or safety based on a lack of illumination – there is a risk that pedestrians will instead walk along Tilstock Road to access the onward footways to the south of the development, resulting in possible vehicle to pedestrian collisions.

Recommendation:

It is recommended that the existing PROW is upgraded to include a bound surface and lighting.

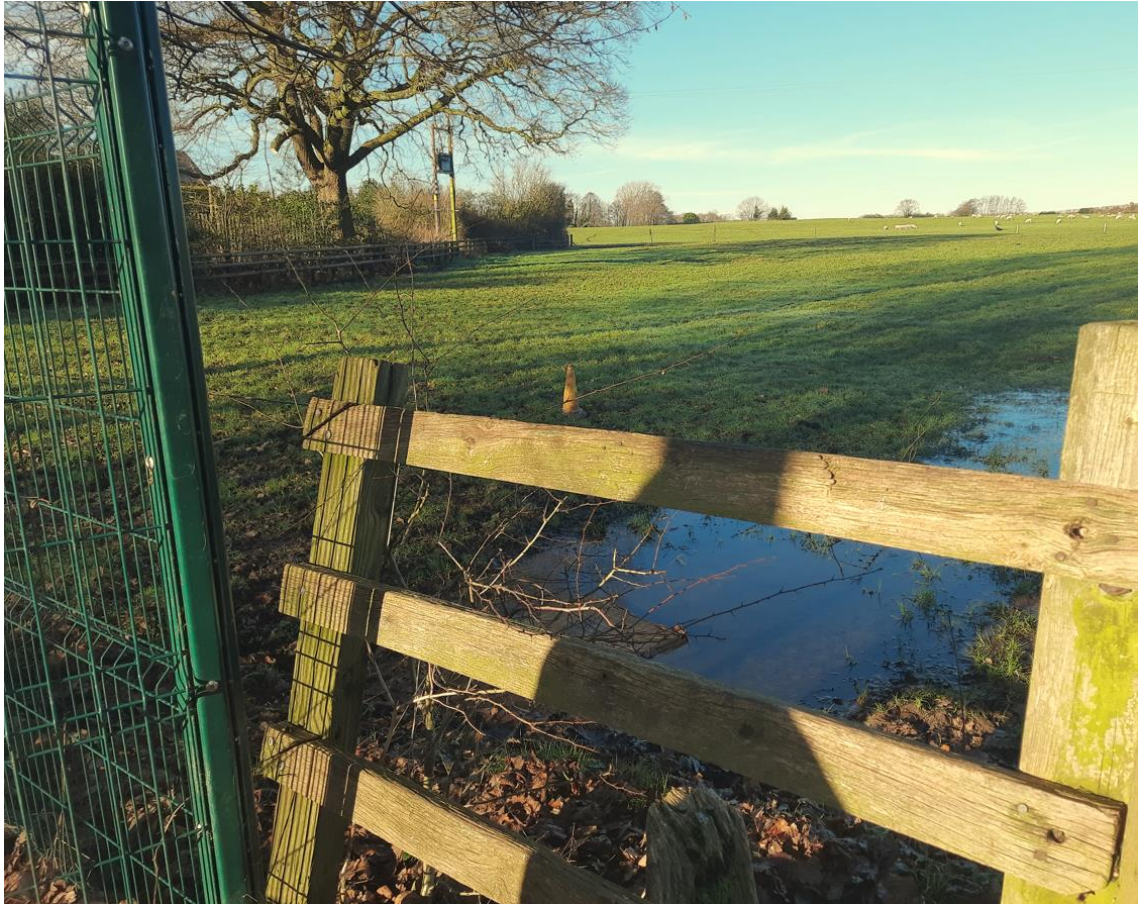
Whilst on site it was observed that the PROW link into the adjacent field and onward route was flooded. It is recommended that, as part of the detailed design, sufficient drainage is provided to ensure that the pedestrian link is available all year round.
