# **GROUND LEVEL TREE ASSESSMENT (GLTA) AND EMERGENCE SURVEY REPORT**

**Albrighton South**

**August 2026**

| <b>Document Reference</b> | BE0010.R.10.2 |

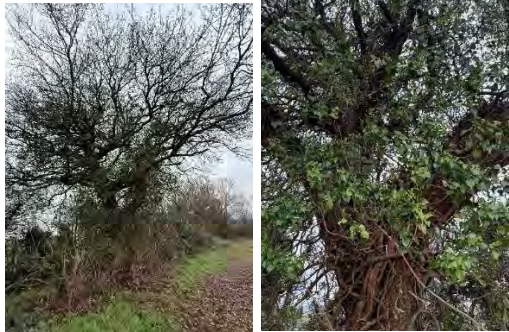
| Tree reference | Feature description | Initial GLTA classification | Original PJA recommendation | Feature photographs |
|---|---|---|---|---|
| T1 | Notes: Ivy cover up trunk. Ivy has root plates providing roosting opportunity between ivy and bark.<br>A full assessment of the trees could not be undertaken. | PRF-I | Recommendation: As per BCT Guidance (Collins, 2023), no further survey is required other than pre-fell aerial inspection immediately prior to felling (if applicable). | |

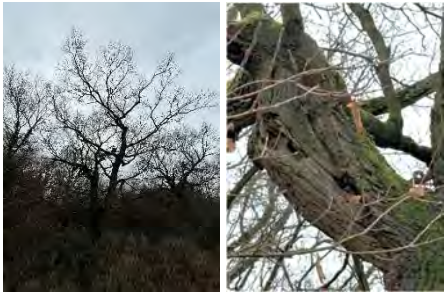
| Tree reference | Feature description | Initial GLTA classification | Original PJA recommendation | Feature photographs |
|---|---|---|---|---|
| T3 | <p>Notes: The tree has numerous defects with a transverse split, flaking bark and tare-outs, all providing roosting opportunity.</p> <p>Some of the tare-outs and the transverse split looks to provide roosting opportunity.</p> | PRF-M | Recommendation: Tree is subject to a suit of emergence surveys. Tree not suitable for aerial inspection. | |

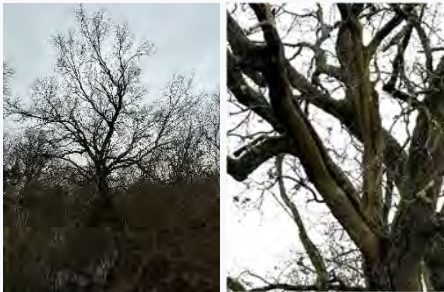
| Tree reference | Feature description | Initial GLTA classification | Original PJA recommendation | Feature photographs |
|---|---|---|---|---|
| T4 | <p>Notes: The tree has numerous defects with a number of areas of bark roll and tare-outs, all providing roosting opportunity.</p> | PRF-M | Recommendation: Tree is subject to a suit of emergence surveys. Tree not suitable for aerial inspection. | |

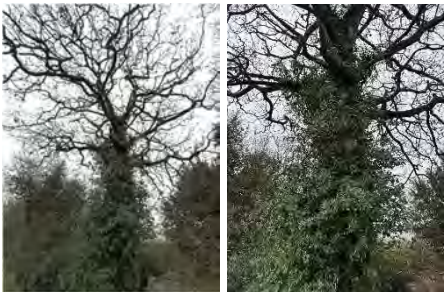
| Tree reference | Feature description | Initial GLTA classification | Original PJA recommendation | Feature photographs |
|---|---|---|---|---|
| T5 | <p>Notes: Ivy cover up trunk. Ivy has root plates providing roosting opportunity between ivy and bark.</p> <p>A full assessment of the trees could not be undertaken.</p> | PRF-I | Recommendation: As per BCT Guidance (Collins, 2023), no further survey is required other than pre-fell aerial inspection immediately prior to felling (if applicable). | |

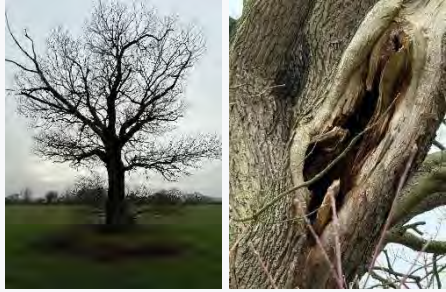
| Tree reference | Feature description | Initial GLTA classification | Original PJA recommendation | Feature photographs |
|---|---|---|---|---|
| T8 | Notes: The tree has a number of identified knot holes, tare outs and areas of lifting bark with desiccation features, all providing roosting opportunity.<br>The tare-out looks to provide access into the main trunk of the tree, providing a larger cavity for roosting opportunity. | PRF-M | Recommendation: tree is subject to a suit of aerial inspection surveys. | |

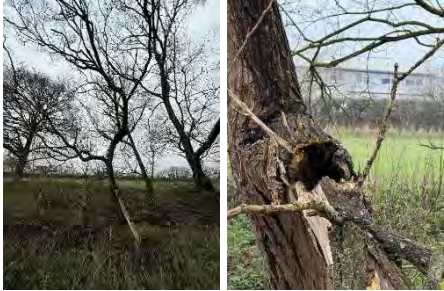
| Tree reference | Feature description | Initial GLTA classification | Original PJA recommendation | Feature photographs |
|---|---|---|---|---|
| T9 | Notes: The tree has a single identified knot hole providing roosting opportunity. | PRF-I | Recommendation: As per BCT Guidance (Collins, 2023), no further survey is required other than pre-fell aerial inspection immediately prior to felling (if applicable). | |

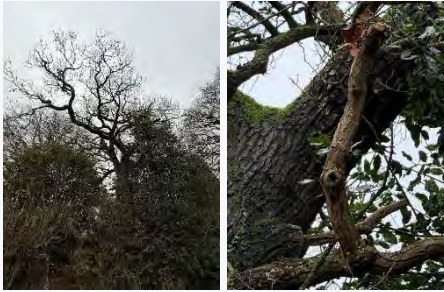
| Tree reference | Feature description | Initial GLTA classification | Original PJA recommendation | Feature photographs |
|---|---|---|---|---|
| T10 | Notes: The tree has a number of identified knot holes and areas of lifting bark with desiccation features, all providing roosting opportunity. | PRF-I | Recommendation: As per BCT Guidance (Collins, 2023), no further survey is required other than pre-fell aerial inspection immediately prior to felling (if applicable). | |

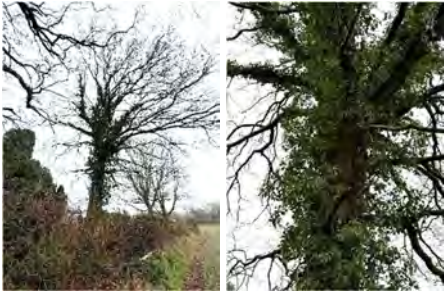
| Tree reference | Feature description | Initial GLTA classification | Original PJA recommendation | Feature photographs |
|---|---|---|---|---|
| T11 | Notes: Ivy cover up trunk. Ivy has root plates providing roosting opportunity between ivy and bark.<br>A full assessment of the trees could not be undertaken. | PRF-I | Recommendation: As per BCT Guidance (Collins, 2023), no further survey is required other than pre-fell aerial inspection immediately prior to felling (if applicable). | |

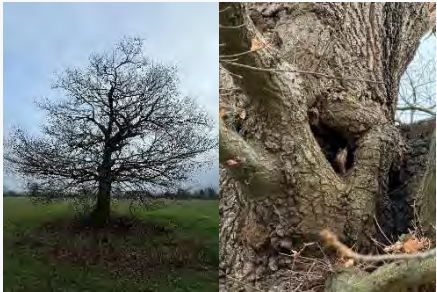
| Tree reference | Feature description | Initial GLTA classification | Original PJA recommendation | Feature photographs |
|---|---|---|---|---|
| T12 | <p>Notes: The tree has a number of identified knot holes, tare outs in main trunk and limbs, potential woodpecker / squirrel holes, transverse-snaps and areas of lifting bark with desiccation features, all providing roosting opportunity.</p> <p>The tare-outs and potential woodpecker / squirrel holes look to provide access into the main trunk and limbs of the tree, providing a larger cavity for roosting opportunity.</p> | PRF-M | Recommendation: tree is subject to a suit of aerial inspection surveys. | |

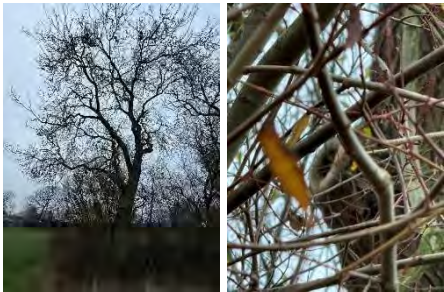
| Tree reference | Feature description | Initial GLTA classification | Original PJA recommendation | Feature photographs |
|---|---|---|---|---|
| T13 | <p>Notes: The tree has a number of identified knot holes providing roosting opportunity.</p> | PRF-I | Recommendation: As per BCT Guidance (Collins, 2023), no further survey is required other than pre-fell aerial inspection immediately prior to felling (if applicable). | |

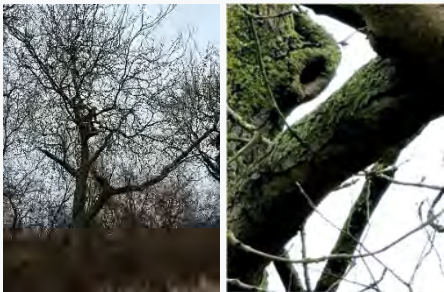
| Tree reference | Feature description | Initial GLTA classification | Original PJA recommendation | Feature photographs |
|---|---|---|---|---|
| T14 | <p>Notes: The tree has a number of identified knot holes and tare outs limbs, all providing roosting opportunity.</p> <p>The tare-outs looks to provide access into main limbs providing a larger cavity for roosting opportunity.</p> | PRF-M | Recommendation: tree is subject to a suit of aerial inspection surveys. | |

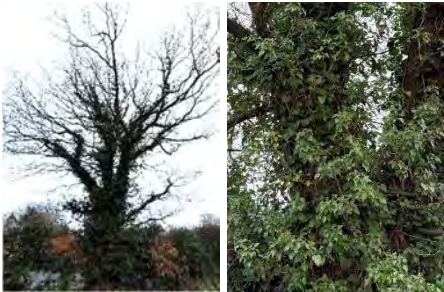
| Tree reference | Feature description | Initial GLTA classification | Original PJA recommendation | Feature photographs |
|---|---|---|---|---|
| T15 | Notes: Ivy cover up trunk. Ivy has root plates providing roosting opportunity between ivy and bark.<br>A full assessment of the trees could not be undertaken. | PRF-I | Recommendation: As per BCT Guidance (Collins, 2023), no further survey is required other than pre-fell aerial inspection immediately prior to felling (if applicable). | |

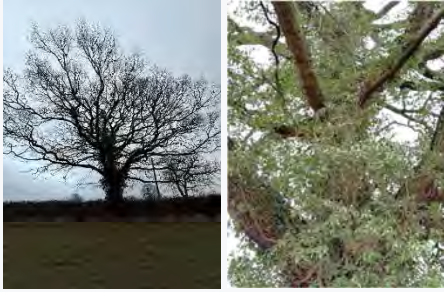
| Tree reference | Feature description | Initial GLTA classification | Original PJA recommendation | Feature photographs |
|---|---|---|---|---|
| T16 | Notes: Ivy cover up trunk. Ivy has root plates providing roosting opportunity between ivy and bark.<br>A full assessment of the trees could not be undertaken. | PRF-I | Recommendation: As per BCT Guidance (Collins, 2023), no further survey is required other than pre-fell aerial inspection immediately prior to felling (if applicable). | |

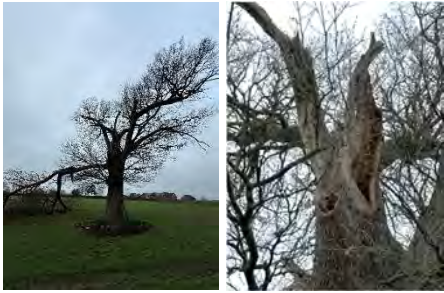
- 3.6 T17 had lost a branch before the emergence surveys commenced. Both survey visits therefore assessed the tree in its altered condition, and the branch failure is not considered a limitation affecting the survey results.

| Tree reference | Feature description | Initial GLTA classification | Original PJA recommendation | Feature photographs |
|---|---|---|---|---|
| T17 | Notes: The tree has a number of identified tare outs, areas of lifting bark with desiccation features, a hollow main stem and transverse-snaps all providing roosting opportunity.<br>The hollow main stem looks to provide access into the main trunk of the tree, providing a larger cavity for roosting opportunity. | PRF-M | Recommendation: tree is subject to a suit of emergence surveys. Tree not suitable for aerial inspection. | |

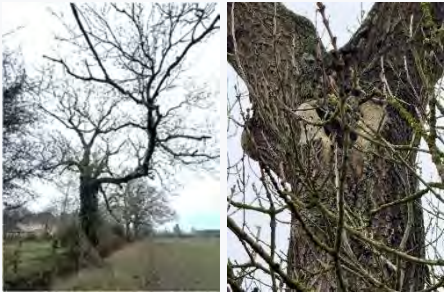
| Tree reference | Feature description | Initial GLTA classification | Original PJA recommendation | Feature photographs |
|---|---|---|---|---|
| T18 | <p>Notes: The tree has a number of identified knot holes and a tare outs, all providing roosting opportunity.</p> <p>The tare-out looks to provide access into the main trunk of the tree, providing a larger cavity for roosting opportunity.</p> | PRF-M | Recommendation: tree is subject to a suit of emergence surveys. Tree not suitable for aerial inspection. | |

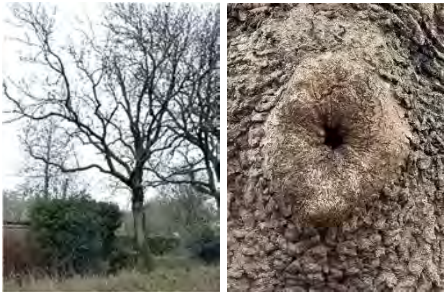
| Tree reference | Feature description | Initial GLTA classification | Original PJA recommendation | Feature photographs |
|---|---|---|---|---|
| T19 | <p>Notes: The tree has a number of identified knot holes providing roosting opportunity.</p> | PRF-I | Recommendation: As per BCT Guidance (Collins, 2023), no further survey is required other than pre-fell aerial inspection immediately prior to felling (if applicable). | |

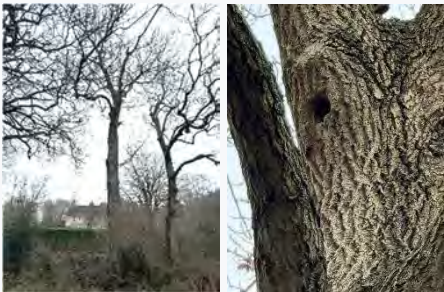
| Tree reference | Feature description | Initial GLTA classification | Original PJA recommendation | Feature photographs |
|---|---|---|---|---|
| T20 | <p>Notes: The tree has a number of identified knot holes, tare outs in main trunk and limbs, potential woodpecker / squirrel hole, transverse-snaps, canker and areas of lifting bark with desiccation features, all providing roosting opportunity.</p> <p>The tare-outs and potential woodpecker / squirrel holes looks to provide access into the main trunk and limbs of the tree, providing a larger cavity for roosting opportunity.</p> | PRF-M | Recommendation: tree is subject to a suit of emergence surveys. Tree not suitable for aerial inspection. | |

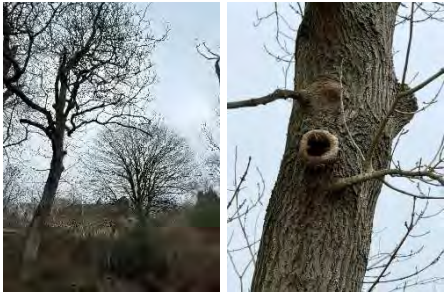
| Tree reference | Feature description | Initial GLTA classification | Original PJA recommendation | Feature photographs |
|---|---|---|---|---|
| T21 | <p>Notes: The tree has a number of identified knot holes and potential woodpecker / squirrel holes all providing roosting opportunity.</p> <p>The potential woodpecker / squirrel holes look to provide access into the main trunk of the tree, providing a larger cavity for roosting opportunity.</p> | PRF-M | Recommendation: tree is subject to a suit of emergence surveys. Tree not suitable for aerial inspection. | |

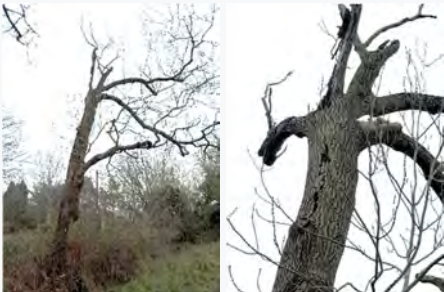
| Tree reference | Feature description | Initial GLTA classification | Original PJA recommendation | Feature photographs |
|---|---|---|---|---|
| T22 | <p>Notes: The tree has a number of identified knot holes and areas of lifting bark with desiccation features. The top of the tree had completely rotted out with all providing roosting opportunity.</p> <p>The knot holes and rotted out top of the tree all provide access into the main trunk of the tree, providing a larger cavity for roosting opportunity.</p> | PRF-M | Recommendation: tree is subject to a suit of emergence surveys. Tree not suitable for aerial inspection. | |

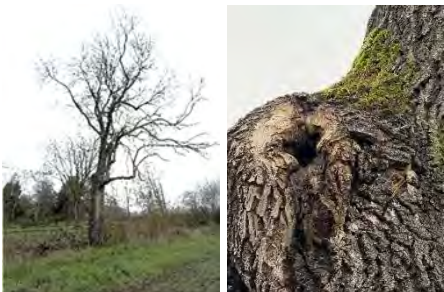
| Tree reference | Feature description | Initial GLTA classification | Original PJA recommendation | Feature photographs |
|---|---|---|---|---|
| T23 | <p>Notes: The tree has a number of identified knot holes and areas of lifting bark with desiccation features, all providing roosting opportunity.</p> <p>The knot holes look to provide access into the main trunk of the tree, providing a larger cavity for roosting opportunity.</p> | PRF-M | Recommendation: tree is subject to a suit of aerial inspection surveys. | |

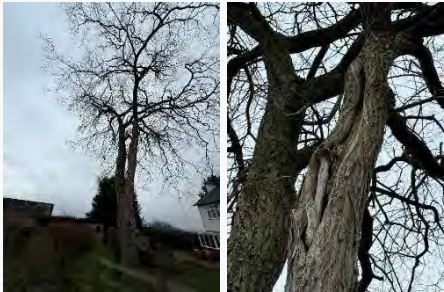
| Tree reference | Feature description | Initial GLTA classification | Original PJA recommendation | Feature photographs |
|---|---|---|---|---|
| T24 | <p>Notes: The tree has a large tare-out and areas of lifting bark, all providing roosting opportunity.</p> <p>The tare-out provides access into the main trunk of the tree, providing a larger cavity for roosting opportunity.</p> | PRF-M | Recommendation: tree is subject to a suit of emergence surveys. Tree not suitable for aerial inspection. | |

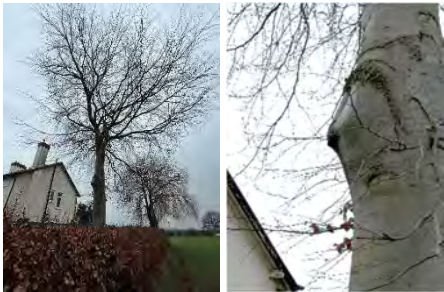
| Tree reference | Feature description | Initial GLTA classification | Original PJA recommendation | Feature photographs |
|---|---|---|---|---|
| T25 | <p>Notes: The tree has a single identified pruning cut providing roosting opportunity.</p> | PRF-I | Recommendation: As per BCT Guidance (Collins, 2023), no further survey is required other than pre-fell aerial inspection immediately prior to felling (if applicable). | |

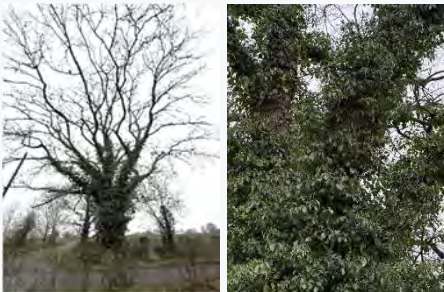
| Tree reference | Feature description | Initial GLTA classification | Original PJA recommendation | Feature photographs |
|---|---|---|---|---|
| T26 | <p>Notes: Ivy cover up trunk. Ivy has root plates providing roosting opportunity between ivy and bark.</p> <p>A full assessment of the tree could not, however, be undertaken.</p> | PRF-I | Recommendation: As per BCT Guidance (Collins, 2023), no further survey is required other than pre-fell aerial inspection immediately prior to felling (if applicable). | |

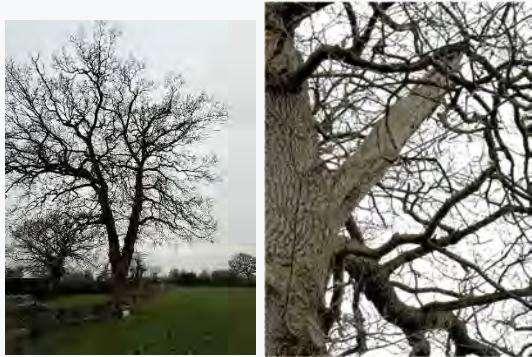
| Tree reference | Feature description | Initial GLTA classification | Original PJA recommendation | Feature photographs |
|---|---|---|---|---|
| T28 | Notes: The tree has a number of areas of lifting bark with desiccation features, providing roosting opportunity. | PRF-I | Recommendation: As per BCT Guidance (Collins, 2023), no further survey is required other than pre-fell aerial inspection immediately prior to felling (if applicable). | |

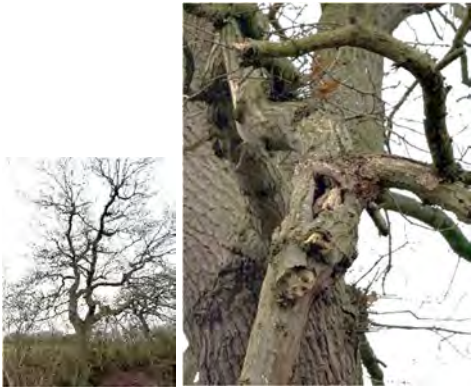
| Tree reference | Feature description | Initial GLTA classification | Original PJA recommendation | Feature photographs |
|---|---|---|---|---|
| T31 | <p>Notes: The tree has a number of identified tare outs, knot holes, rotting limbs and areas of lifting bark, providing roosting opportunity.</p> <p>The knot holes and rotting limbs look to provide access into the main trunk / limbs of the tree, providing a larger cavity for roosting opportunity.</p> | PRF-M | Recommendation: tree is subject to a suit of aerial inspection surveys. | |

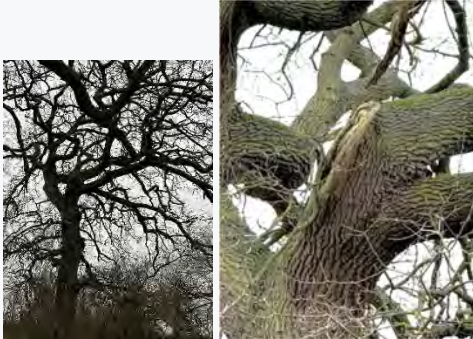
| Tree reference | Feature description | Initial GLTA classification | Original PJA recommendation | Feature photographs |
|---|---|---|---|---|
| T32 | <p>Notes: The tree has an identified healed tare out and areas of lifting bark, providing roosting opportunity.</p> | PRF-I | Recommendation: As per BCT Guidance (Collins, 2023), no further survey is required other than pre-fell aerial inspection immediately prior to felling (if applicable). | |

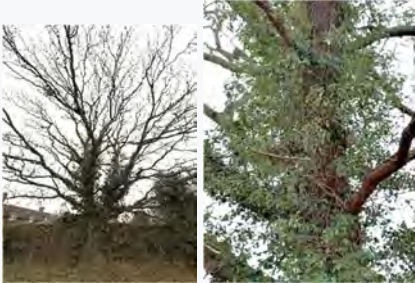
| Tree reference | Feature description | Initial GLTA classification | Original PJA recommendation | Feature photographs |
|---|---|---|---|---|
| T34 | <p>Notes: Ivy cover up trunk. Ivy has root plates providing roosting opportunity between ivy and bark.</p> <p>A full assessment of the trees could not be undertaken.</p> | PRF-I | Recommendation: As per BCT Guidance (Collins, 2023), no further survey is required other than pre-fell aerial inspection immediately prior to felling (if applicable). | |

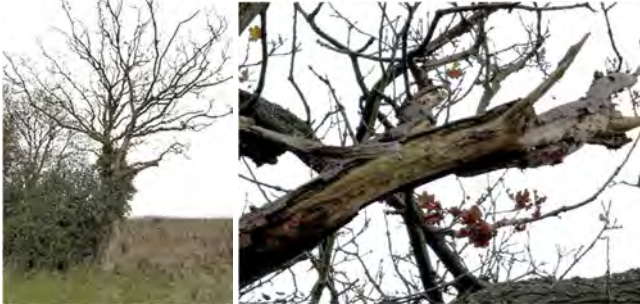
| Tree reference | Feature description | Initial GLTA classification | Original PJA recommendation | Feature photographs |
|---|---|---|---|---|
| T35 | <p>Notes: Ivy cover up trunk and lifting bark. Ivy has root plates providing little roosting opportunity between ivy and bark.</p> <p>A full assessment of the tree could not, however, be undertaken.</p> | PRF-I | Recommendation: As per BCT Guidance (Collins, 2023), no further survey is required other than pre-fell aerial inspection immediately prior to felling (if applicable). | |

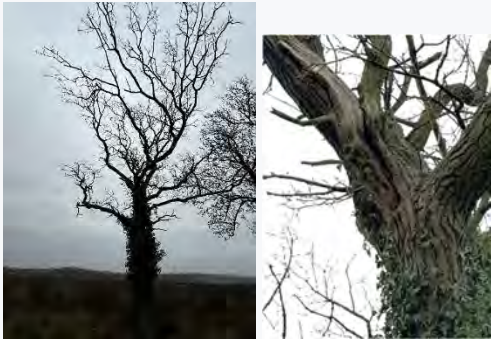
| Tree reference | Feature description | Initial GLTA classification | Original PJA recommendation | Feature photographs |
|---|---|---|---|---|
| T36 | <p>Notes: Ivy cover up trunk and a desiccated tare-out. Ivy has root plates providing roosting opportunity between ivy and bark.</p> <p>A full assessment of the tree could not, however, be undertaken.</p> | PRF-I | <p>Recommendation: As per BCT Guidance (Collins, 2023), no further survey is required other than pre-fell aerial inspection immediately prior to felling (if applicable).</p> | |

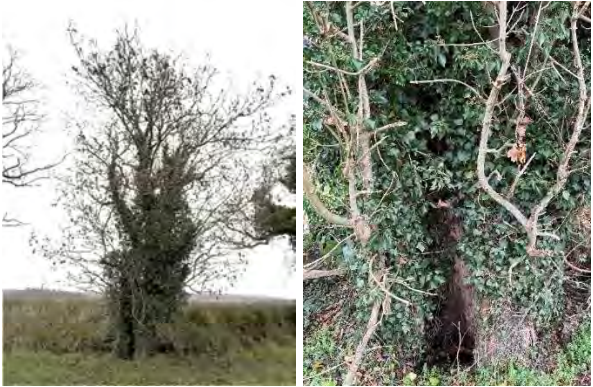
| Tree reference | Feature description | Initial GLTA classification | Original PJA recommendation | Feature photographs |
|---|---|---|---|---|
| T37 | <p>Notes: Ivy cover up trunk and butt rot. Ivy has relatively thick root plates providing roosting opportunity between ivy and bark.</p> <p>The butt rot provides access into the main trunk of the tree, providing a larger cavity for roosting opportunity.</p> | PRF-M | <p>Recommendation: tree is subject to a suit of emergence surveys. Tree not suitable for aerial inspection.</p> | |

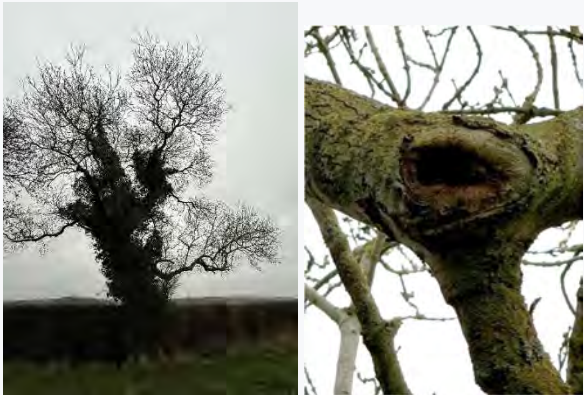
| Tree reference | Feature description | Initial GLTA classification | Original PJA recommendation | Feature photographs |
|---|---|---|---|---|
| T38 | <p>Notes: Ivy cover up trunk, knot hole and a tare out on a minor limb. Ivy has root plates providing roosting opportunity between ivy and bark.</p> <p>A full assessment of the tree could not, however, be undertaken.</p> | PRF-I | <p>Recommendation: As per BCT Guidance (Collins, 2023), no further survey is required other than pre-fell aerial inspection immediately prior to felling (if applicable).</p> | <p>The first photograph shows a full view of tree T38, which is heavily covered in ivy. The second photograph is a close-up of a knot hole in the tree's trunk, showing a dark, hollowed-out area.</p> |

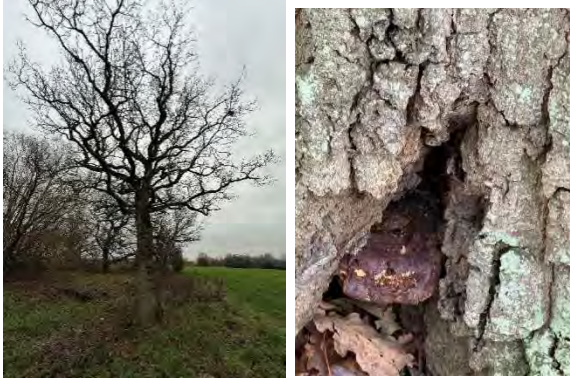
| Tree reference | Feature description | Initial GLTA classification | Original PJA recommendation | Feature photographs |
|---|---|---|---|---|
| T39 | <p>Notes: Butt rot at base of tree and a number of knot holes all providing roosting opportunity.</p> <p>Butt rot does not appear to provide a cavity up into the tree.</p> | PRF-I | <p>Recommendation: As per BCT Guidance (Collins, 2023), no further survey is required other than pre-fell aerial inspection immediately prior to felling (if applicable).</p> | <p>The first photograph shows a full view of tree T39, which is heavily covered in ivy. The second photograph is a close-up of the base of the tree, showing significant butt rot and a large, dark, hollowed-out area.</p> |

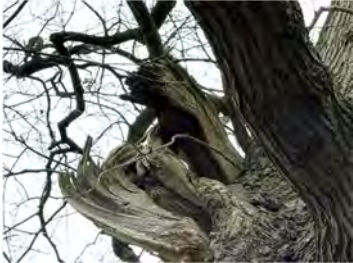
| Tree reference | Feature description | Initial GLTA classification | Original PJA recommendation | Feature photographs |
|---|---|---|---|---|
| T41 | <p>Notes: The tree has a number of identified knot holes, tare outs, transverse splits and lifting bark and a desiccation crack all providing roosting opportunity.</p> <p>The knot holes, tare outs and transverse splits look to provide a larger cavity for roosting opportunity.</p> | PRF-M | Recommendation: tree is subject to a suit of aerial inspection surveys. | |

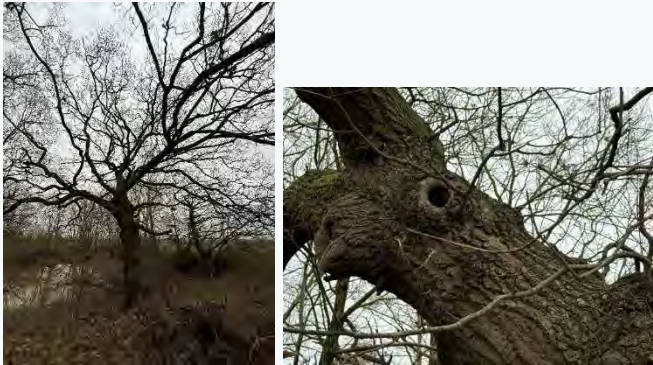
| Tree reference | Feature description | Initial GLTA classification | Original PJA recommendation | Feature photographs |
|---|---|---|---|---|
| T42 | <p>Notes: The tree has a number of identified knot holes, tare outs, transverse splits and lifting bark and a desiccation crack all providing roosting opportunity.</p> <p>The knot holes, tare outs and transverse splits look to provide a larger cavity for roosting opportunity.</p> | PRF-M | Recommendation: tree is subject to a suit of aerial inspection surveys. | |

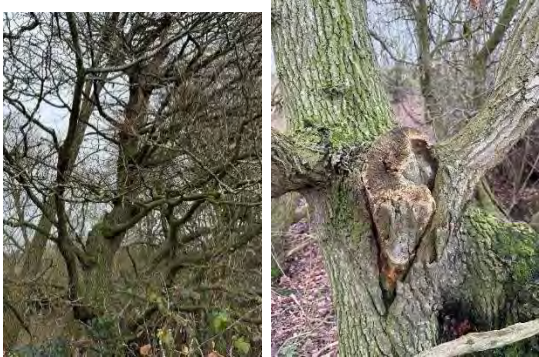
| Tree reference | Feature description | Initial GLTA classification | Original PJA recommendation | Feature photographs |
|---|---|---|---|---|
| T43 | <p>Notes: The tree has a number of identified tare outs, pruning cuts, transverse splits and lifting bark and a desiccation crack all providing roosting opportunity.</p> <p>The tare outs, pruning cuts and transverse splits look to provide a larger cavity for roosting opportunity.</p> | PRF-M | Recommendation: tree is subject to a suit of aerial inspection surveys. | |

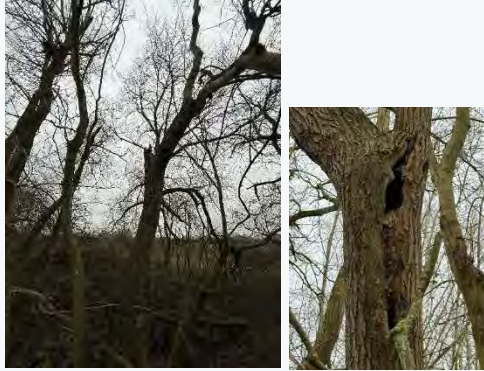
| Tree reference | Feature description | Initial GLTA classification | Original PJA recommendation | Feature photographs |
|---|---|---|---|---|
| T44 | <p>Notes: The tree has a number of identified potential woodpecker / squirrel holes and cavity in main trunk of the tree from a tear out all providing roosting opportunity.</p> <p>The woodpecker / squirrel holes and cavity in main trunk of the tree from a tear out looks to provide access into the main trunk of the tree, providing a larger cavity for roosting opportunity.</p> | PRF-M | Recommendation: tree is subject to a suit of emergence surveys. Tree not suitable for aerial inspection. | |

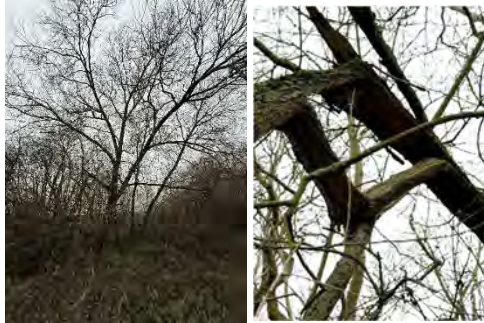
| Tree reference | Feature description | Initial GLTA classification | Original PJA recommendation | Feature photographs |
|---|---|---|---|---|
| T45 | <p>Notes: A single transverse snap on a minor limb providing roosting opportunity.</p> | PRF-I | Recommendation: As per BCT Guidance (Collins, 2023), no further survey is required other than pre-fell aerial inspection immediately prior to felling (if applicable). | |

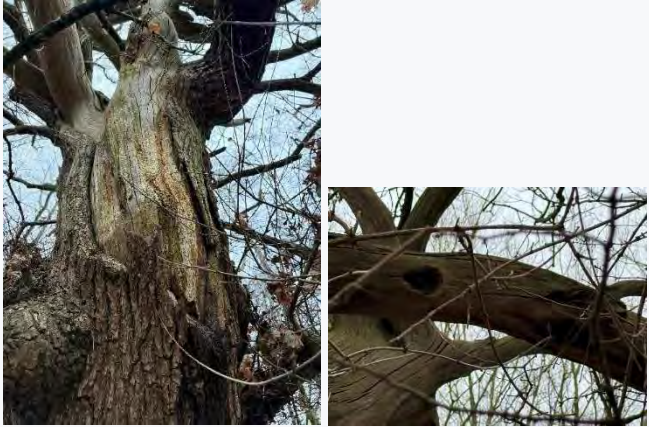
| Tree reference | Feature description | Initial GLTA classification | Original PJA recommendation | Feature photographs |
|---|---|---|---|---|
| T46 | <p>Notes: The tree has a number of identified knot holes, tare outs, areas of lifting bark and a desiccation crack all providing roosting opportunity.</p> <p>The tare outs, areas of lifting bark look to provide access into the main trunk / limbs of the tree, providing a larger cavity for roosting opportunity.</p> | PRF-M | Recommendation: tree is subject to a suit of emergence surveys. Tree not suitable for aerial inspection. | |

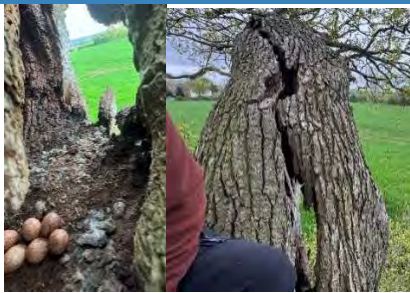
| Tree reference | Species | Initial GLTA classification | Classification following ATI | Change in assessment | Description | Photos |
|---|---|---|---|---|---|---|
| T8 | Pedunculate oak | PRF-M | PRF-M | No change | <p>Numerous features present on tree. Given the size of the features it is likely they can't be fully inspected by endoscope.</p> <p>Kestrel nest (c.6) in large tear out cavity at 4m on eastern aspect.</p> <p>Aborted climb to prevent disturbance.</p> <p>Recommend emergence surveys</p> | |

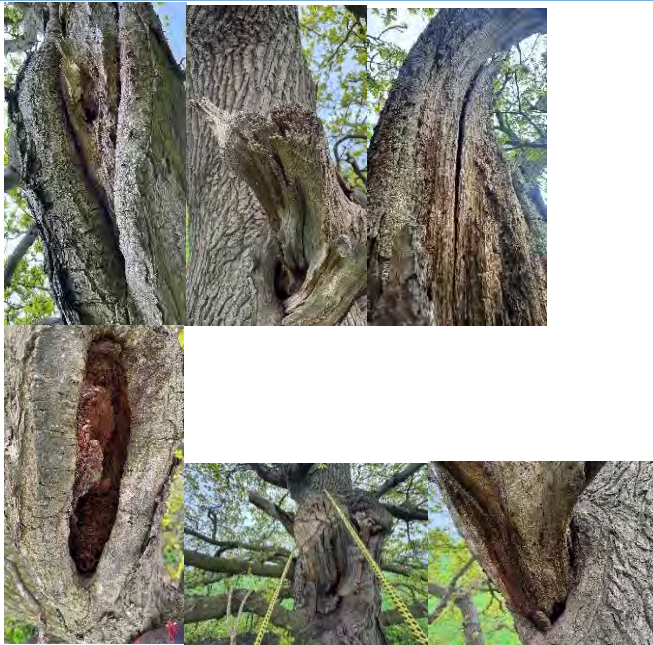
| T12 | Pedunculate oak | PRF-M | PRF-M | No change | <p>1. Tear out at 5m on northern aspect. Large cavity with multiple entrances and numerous cavities within. Well sheltered and dry. Suitable for multiple bats, but no evidence noted. PRF-M.</p> <p>2. Dead limb (previously trimmed) at 6m on NE aspect. Cavity at base with blue tit nest (c8). Additional cavity on southern side which extends in 20cm to well sheltered cavity. Suitable for multiple bats. PRF-M.</p> <p>3. Cavity at 4m on southern aspect. Large cavity but no roosting opportunities. None</p> <p>4. Partially dead limb at 8m on eastern limb. Narrow fissure 1m long; only 10cm is sheltered enough for bats. PRF-I.</p> <p>5. Hollow dead limb on northern aspect at 12m. Mostly unsuitable due to exposure, however hollows to a point where 1 bat could roost. PRF-I</p> <p>6. Tear out at 14m on western aspect. Feature superficial and unsuitable for bats.</p> | |

| Date | Target | Sunset Time | Temp Start / End | Weather | Results |
|---|---|---|---|---|---|
| 12/05/2026 | T12 | 20:54 | 9°C / 8°C | 50–55% cloud, Beaufort 1 wind and dry | No bats were observed emerging from or re-entering T12 and no behaviour indicative of roosting was recorded.<br><br>Bat activity in the vicinity of the tree was limited and did not indicate association with any of the identified PRFs. |

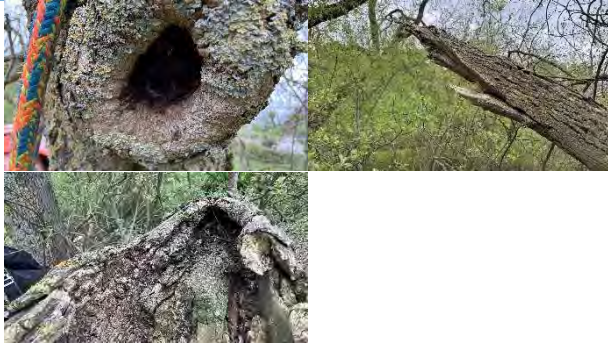
| T14 | Pedunculate oak | PRF-M | None | PRF not confirmed | <p>1. Tear out at 3m on SE limb. Superficial and unsuitable for bats. None.</p> <p>2. Tear out at 5m on SW limb. Superficial and unsuitable for bats. None.</p> <p>3. Knot hole at 7m on SE aspect of stem. Superficial and unsuitable for bats. None</p> | |

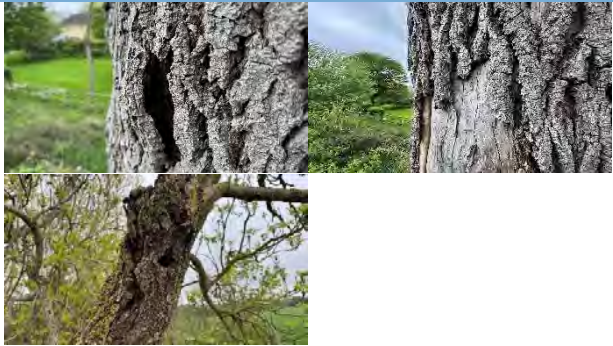
| T23 | Pedunculate oak | PRF-M | PRF-I | Reduced suitability | <p>1. Knot holes (various): all superficial and unsuitable for use by bats. None</p> <p>2. Flaking bark at 2-3m on W aspect. Low suitability for individual bat. No evidence noted. PRF-I.</p> <p>3. Dead stub at 10m on S aspect. Entrance to cavity 5cm, which opens out to 10cm. Partially open topped so reduces suitability, but still suitable for low numbers of bats. PRF-I.</p> | |

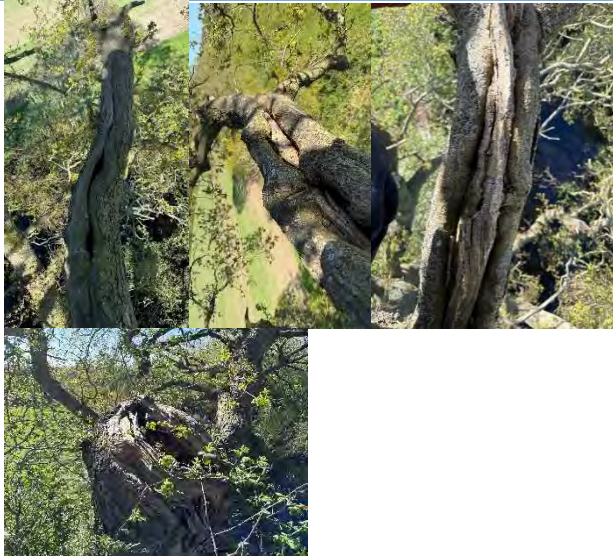
| T31 | Pedunculate oak | PRF-M | PRF-M | No change | <p>1. Knot hole at 4m on eastern aspect. Dead limb. Downward facing. Entrance 4cm, extends in 7cm to a point. No evidence of bats. Suitable for individual. PRF-I.</p> <p>2. Callus roll at 10m on northern leading limb; east facing. Upwards facing. Cavity is largely open and unsuitable for bats. Small area of narrow enclosed crevice in deadwood and callus roll where single bat may roost. No evidence. PRF-I.</p> <p>3. Upward facing callus roll at 9m on western leading limb. Well sealed presenting no opportunities for roosting bats. None.</p> <p>4. Snapped limb with remaining deadwood at 9m on western limb. Fissures in deadwood but exposed to poor weather and unsuitable for roosting bats. None</p> <p>5. Tear out at 11m on eastern aspect. Superficial and no suitability for bats. None.</p> <p>6. Upward facing callus roll at 13m. Superficial with no suitability for bats. None</p> <p>7. Snapped limb with remaining deadwood at 13m on southern aspect at crown. Fissures in deadwood but exposed to poor weather and unsuitable for roosting bats. None</p> <p>8. Downward facing knot hole at 8m on western leading limb. Entrance 4cm, extend horizontally both directions, up to 50cm. PRF-M, but blue tit nesting so inspection not possible. Recommend emergence surveys. 2 surveyors.</p> <p>9. Callus roll around dead limb, south western facing at 7m above crown. Superficial and sealed.</p> <p>10. Tear out with dead wood fissures and cavity at 7m on southern leading limb. Cavity extends in 10cm. Suitable for individual bats. PRF-I.</p> <p>11. Open topped tear out cavity at 5m on southern limb. Large bowl shaped feature with likely squirrel drey. Some areas of dead wood with minor fissures but unsuitable for bats. None.</p> <p>12. Various dead wood limbs on southern leading limb. All unsuitable for bats.</p> | |

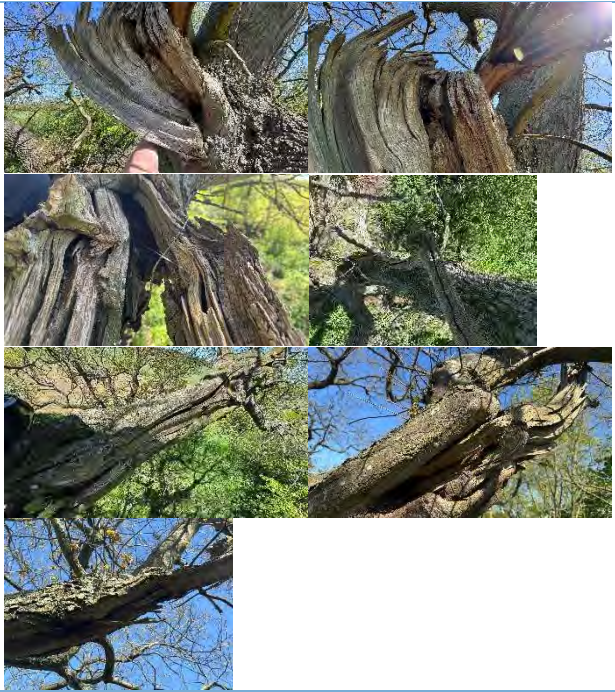
| T41 | Pedunculate oak | PRF-M | PRF-M | No change | <p>1. Snapped limb with tear out and deadwood with fissures. 9m on southern aspect. Downward leading cavity which leads into water filled pot. Numerous fissures associated with feature; the majority are too exposed to be used by bats, but there are a low number of opportunities for individual bats. No evidence noted. PRF-I</p> <p>2. Tear out at 11m on SE limb. Deadwood attached to the top which has various fissures, only 1 of which is suitable for bats. Cavity extends downwards at least 15cm. Filled with vegetation and blue tit nest. PRF-I.</p> <p>3. Tear out at 14m on NE aspect of southern limb. Minor fissures present but no suitability for bats. None.</p> <p>4. Dead limb in crown with fissure suitable for low number of bats. PRF-I</p> <p>5. Dead curved limb in crown. Entrance to cavity on SW end with deadwood protruding. Cavity extends in at least 1m; entrance 6cm, cavity is between 5 and 2cm diameter (variable). Second smaller entrance on underside. No evidence of bats but suitable for multiple. Cannot fully inspect with endoscope. PRF-M.</p> <p>6. Partially dead limb with callus roll on NE limb. All sealed with no suitability for bats.</p> <p>7. Various dead limbs with fissures. Majority are unsuitable or exposed, but some present suitability for individual bats. PRF-I.</p> <p>8. Callus roll and deadwood at 8m on northern limb. Side facing. Relatively exposed to wind and rain, but suitable for low numbers of bats in crevice between deadwood fissure. No evidence of bats. PRF-I</p> | |

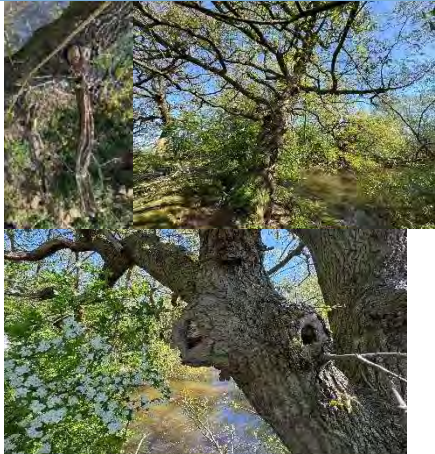
| T42 | Pedunculate oak | PRF-M | None | PRF not confirmed | <p>1. Knot hole at 6m, NW facing. Entrance 2cm with squirrel chew marks. Feature only extends inwards 3cm and assessed as unsuitable for bats. None.</p> <p>2. Dead limbs on SW aspect. Superficial fissures. Unsuitable for bats.</p> <p>3. Tear out at 5m on southern aspect. Fully sealed presenting no opportunity for bats.</p> <p>4. 2 knot holes on western aspect at 5m. Both superficial with no suitability for roosting bats.</p> | |

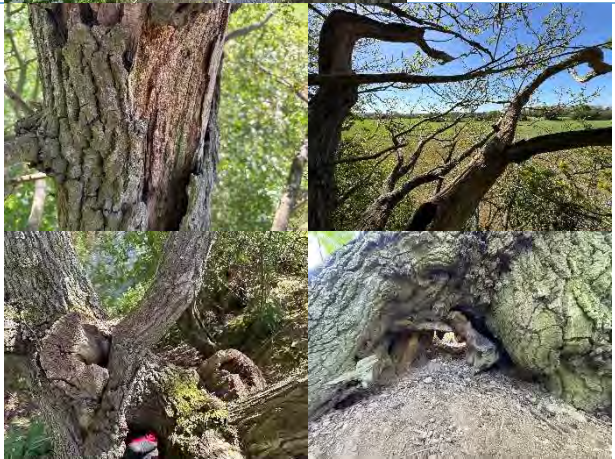
| T43 | Pedunculate oak | PRF-M | PRF-M | No change | <p>1. Basal cavity. Multiple cavities that appear to interlink. Cannot fully inspect. Sufficient size for multiple bats. No evidence noted. PRF-M. Emergence survey required.</p> <p>2. 2 pruning cuts at 1.5m on S aspect. No suitability for roosting bats.</p> <p>3. Flaking bark at 6m in crown. Some is superficial but 3 locations where individual bat may roost. No evidence noted. PRF-I</p> <p>4. Various dead branches. Superficial fissures unsuitable for use by bats.</p> | |
