**SHREWSBURY TOWN CENTRE CONSERVATION AREA**

**SPECIAL CHARACTER AREA ASSESSMENT**

**FRANKWELL**

**SPECIAL CHARACTER AREA 10**

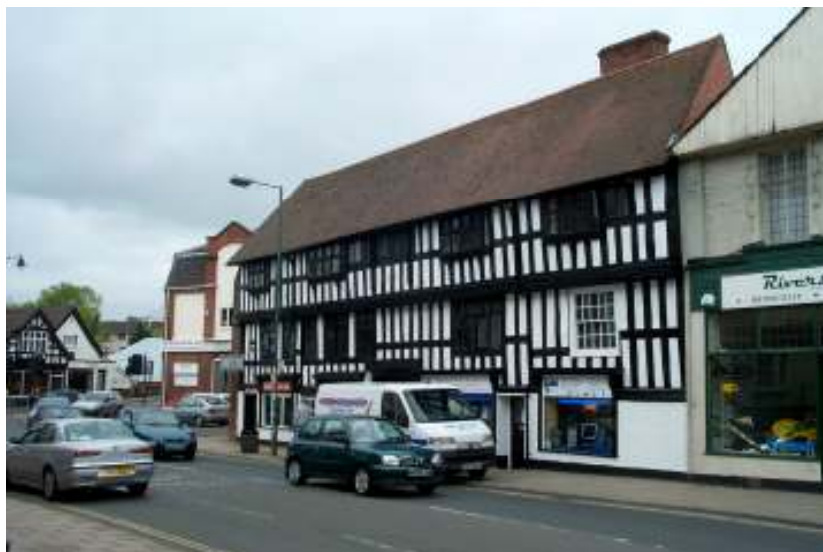
**FIGURE 2:** The Fellmongers

It faces the main street, with easy access to the river for washing the sheep skins (fells) and transporting them to all part of England and overseas. The building was used for this purpose from 1580 until 1971 when the last Fellmongers company ceased trading.

The premises were used for both trade and accommodation purposes. The close-studded and jettied frontage block provided four separate ground floor shops with the wool store and workshops housed in much plainer premises behind.

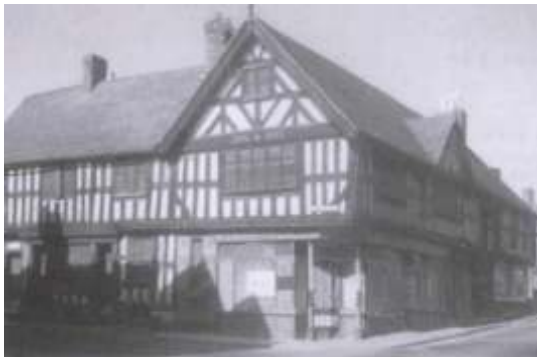
**Figure 4: The String and Horses**

A building built by John Worrall in 1576-7 can be seen in the map. This standalone building during the 18<sup>th</sup> Century was called the String & Horses, a public house later to be used as a supermarket, known as the Co-op. The building was removed in the 1960's to make way for a traffic roundabout, and it has been rebuilt at Avoncroft Museum, Worcester.

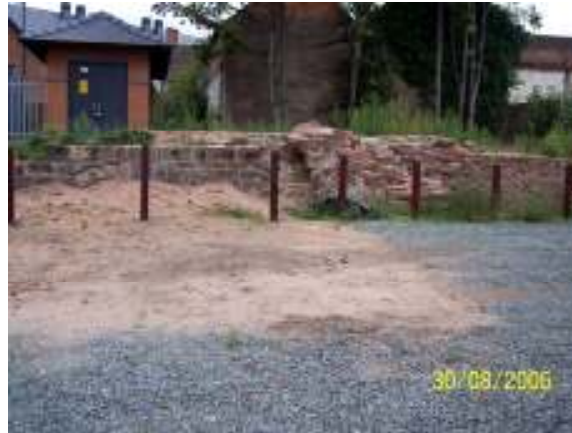
Within Frankwell Quay area, the remains of St. George's Bridge can be found behind what is now the Tyre Depot. St. George's bridge crossed the river to what is now Frankwell Quay and consisted of seven arches, with huge towers at each end. Part of this bridge remains today and should be recommended for consideration as a scheduled ancient monument.

**FIGURE 8:** Remains of St. George's Bridge, in need of protection.

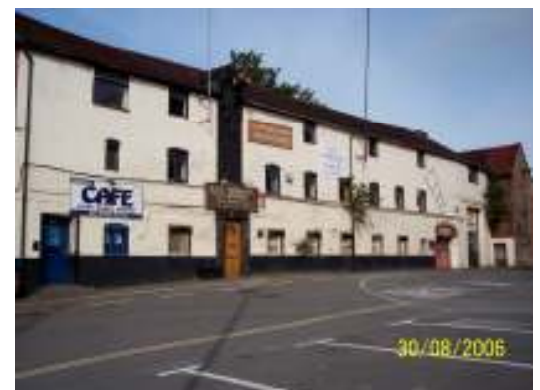
**Figure 10:** The Glen today

With reference to industrial archaeology, "malting was the most characteristic of market town manufacturers" (TRINDER 1996 p47). In Shrewsbury several maltings can still be identified. Of particular interest is The Glen in Frankwell Quay. John Hughes operated this malting between 1836 and 1855. The premises comprises a "three-storey, twelve bay, double malt house in red brick a with a clay tile roof" (TRINDER 1996 P50). Today this building remains intact with various tenants occupying it.

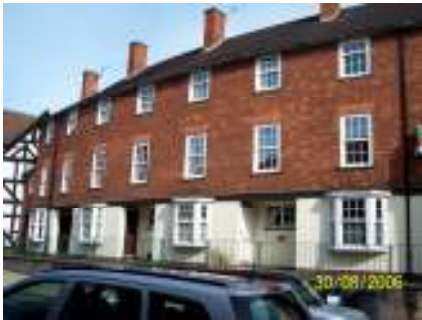
**FIGURE 12:** Natty Price's Corner as it looks today.

Frankwell begins with the strong horizontal emphasis of the terraced properties such as Natty Price's Corner, punctuated by the vertical proportions of box sash windows and steeply pitched dormers. In the early 1960's Natty Price's Corner was demolished due to it becoming waterlogged annually, and replaced with council flats built above flood level. The building went on to win an award for keeping the character of the area.

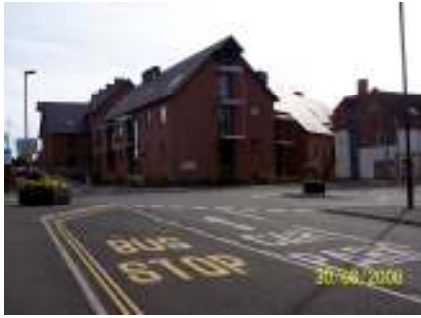
The Frankwell Quay car park to the east of Frankwell detracts from the character of the residential and commercial area. Due to the inherent problems of flooding and the uncertainty as to its long term future as a car park, the area would not benefit from being landscaped. This area has great potential, however and it must be remembered that the open space within the fabric of an area is as important as the building themselves.

**FIGURE 16:** The New Guildhall with The Glen Maltings In view.

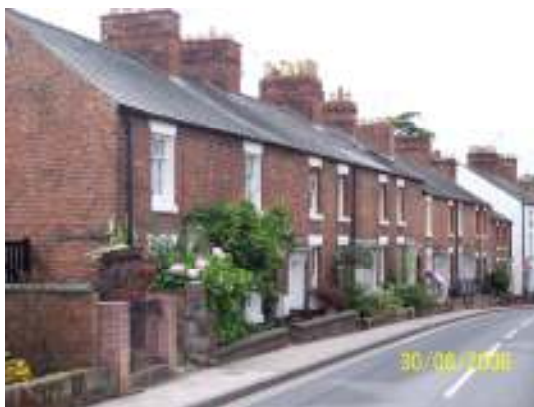
**FIGURE 22:** New Street, two storey terraces giving a uniformed appearance.

To the west of Frankwell is New Street, this area comprises of mainly late eighteenth and early nineteenth century buildings. The street has an uniformed appearance as it is lined with terraces dating from 1840, with the majority being two storeys high.

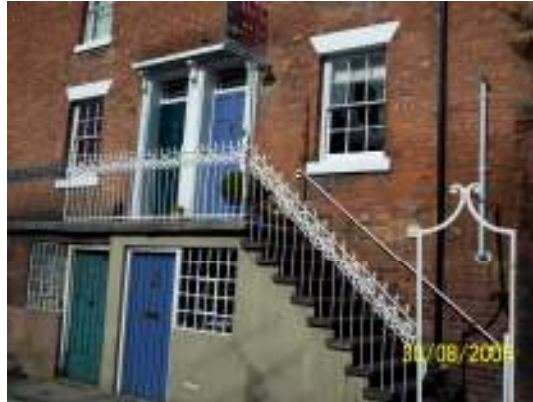
On approach, the street has an intimate feel and picturesque appearance as the massing of the terraces is relatively dense, and ornate cast iron railings exist on some of the dwellings.

**FIGURE 24:** New Street, ornate wrought iron railings.

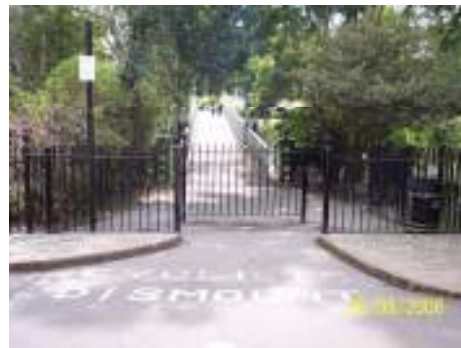
**FIGURE 26:** Entrance to Porthill Suspension bridge, contrast to existing ornate railings in the area.

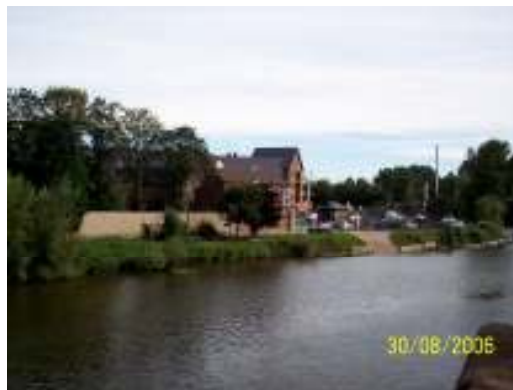
This, unfortunately, can not be said of Frankwell Quay, which although has mature landscaping, has not reached its full potential as an attractive riverside.

**FIGURE 28:** Frankwell Quay, from The Welsh Bridge

The largest amount of open space is to be found at Frankwell Quay, which is predominantly used as a car park. Although the cars are visually intrusive upon the area, the riverside itself has a number of mature trees shielding the car park when looking from Smithfield Road.

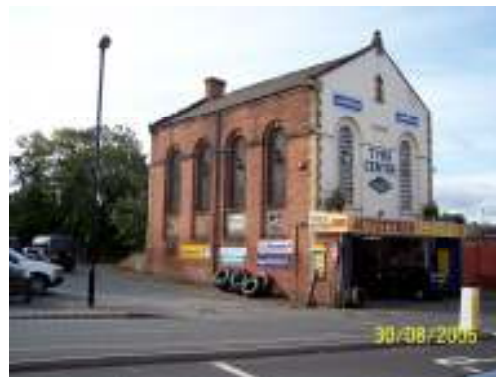
**FIGURE 29:**

- The street furniture. This consists of a number of differing designs and periods thus resulting in a visual conflict, i.e. The placing of concrete litter bins and bollards next to buildings of high architectural quality.
- The intrusive signage near to buildings of high architectural quality, for example the old chapel, today known as the Tyre Centre, are visually intrusive amongst the collection of densely packed late sixteenth century timber framed buildings.

The Chapel, today the tyre depot.

- The replacement of totally unsympathetic concrete litter bins with less intrusive period bins made of metal.
- Clearer public signage to direct non-locals into and through the area.
- Re-development of Frankwell Quay.
- Further consideration of the impact of traffic controls and signage in the visual amenity of the area.

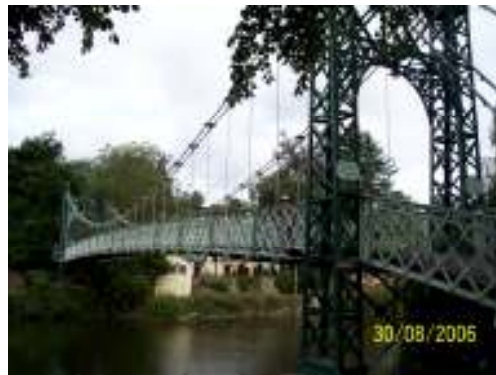
**FIGURE 30:**

- The banks of the river near the Porthill Bridge and Frankwell Quay need attention, as the streetscape is in a poor condition, more so at Frankwell Quay. They are generally not fulfilling their potential.
- Porthill Suspension Bridge, traffic markings in some places are visually obtrusive, on both the road and carriageway. Scaring of the pathway can be seen in this photograph, with the insensitive replacement of modern railings. An overall mismatch in design of railings can be seen in the whole area.

Porthill Suspension Bridge.

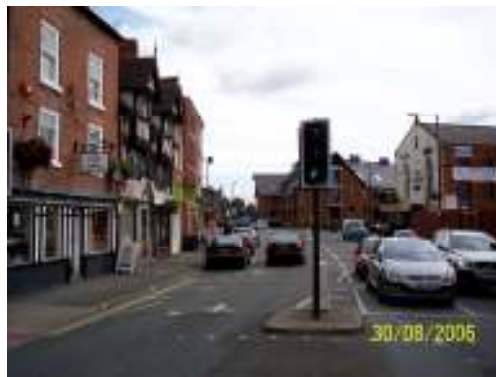
As one enters the car park, the framework of streets becomes almost non-existent and there is also a very weak entrance to the car park.

**FIGURE 31:** Looking into Frankwell Quay Car Park, note the traffic.

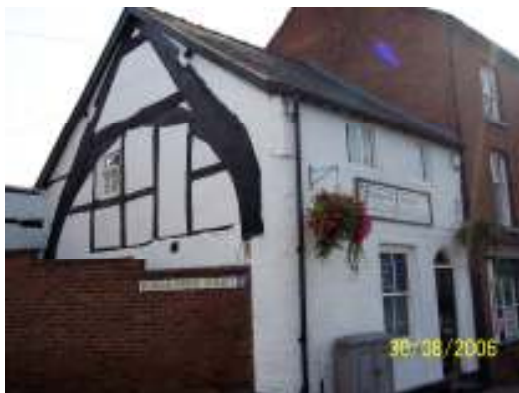
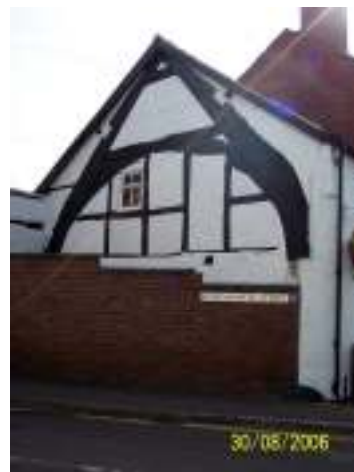
The area immediately adjacent to the Welsh Bridge in the suburb of Frankwell contains examples of the more primitive looking cruck frame buildings. Debate surrounding the dating of the cruck frames continues, but it can be said with some certainty that Frankwell's rare examples are medieval. An excellent example of a medieval cruck frame is exposed in the gable end of 92 Frankwell.

**FIGURE 32 (2):** 92 Frankwell  
A cruck frame exposed in the gable end.

A cruck frame is made out of a large timber, which is sawn in half to produce two identical shaped pieces of timber. These are then jointed by a collar beam to form an A-frame from which the entire building is supported.

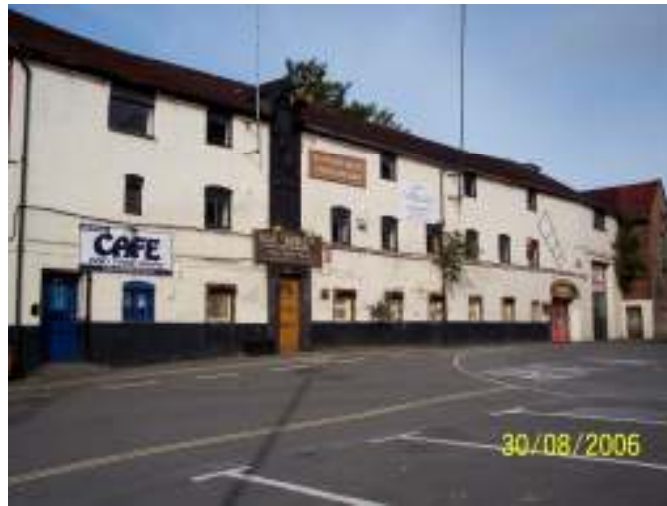
- An important building is The Glen, situated in Frankwell Quay. This building is regarded as one of the largest maltings of its time in Shropshire. The premises comprise a three-storey, twelve bay, double malthouse in red brick with a clay tile roof.

The building is a good example of a building of its period, and is worthy of listing status.

**FIGURE 33:** The Glen, the largest malting of its time in Shropshire.

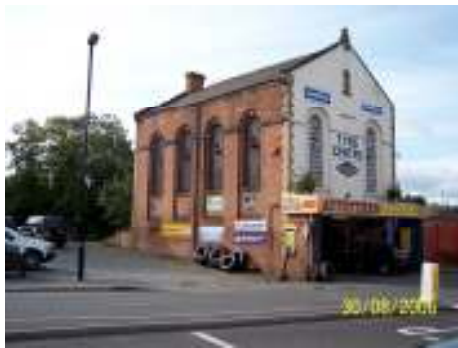
- A further important building is the Chapel near to Frankwell Car Park, today this building houses a tyre depot. The building has local and historical importance for the area. The remains of the old George Bridge are also situated to the rear of this building.

**FIGURE 34:** The Old Chapel, today a tyre depot

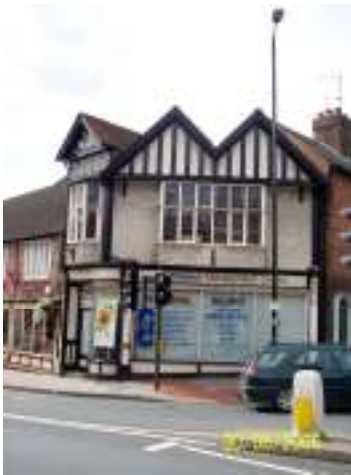
- The empty shop premises situated on the roundabout, formerly known as Rowsons, has superb curvilinear glass work and plays a focal part in the townscape of the street Frankwell.

**FIGURE 36:** 25 Frankwell  
Rowsons old store..

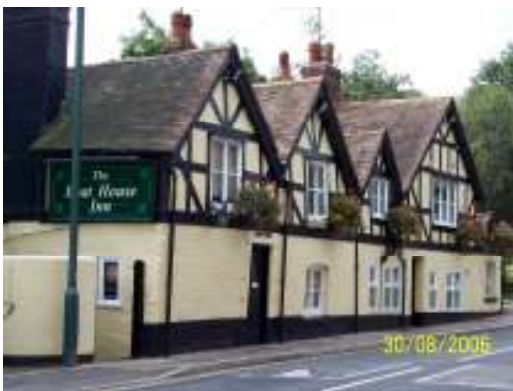
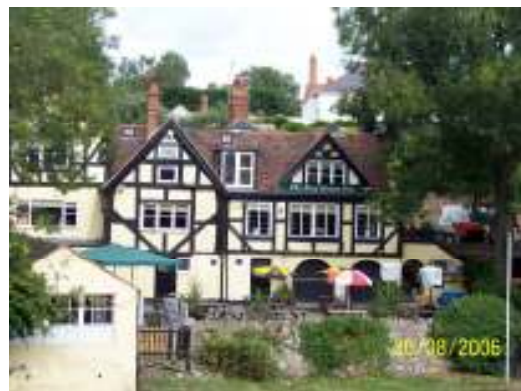
**FIGURE 38 & 39:** The Boat House Inn, Port Hill

- The building on the left was first a tea room, then a landing stage for pleasure boats, next a boat house, and is now used as a public house. Ferries used to operate between this Inn and the Quarry bank of the Severn – the only method of crossing at that point, until the suspension bridge was built in 1923 (1991, Shropshire Records & Research Unit).

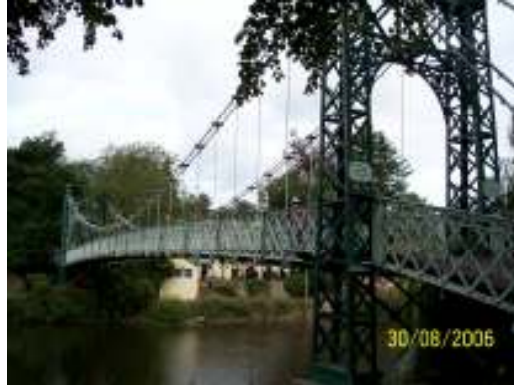
- The Porthill Suspension Bridge could also be considered for listed status. Since its opening in 1923 the bridge has served as a gateway for thousands of visitors to the Flower Show, and for the residents of Porthill. The bridge is of historical and local importance. Not only did the residents of Porthill contribute towards its cost, it also marked the end of the ferry boat service which had operated for over two hundreds years.

**FIGURE 40:** Porthill Suspension Bridge
