# **GROUND LEVEL TREE ASSESSMENT (GLTA) AND EMERGENCE SURVEY REPORT**

**Albrighton South**

**August 2026**

| <b>Document Reference</b> | BE0010.R.10.2 |

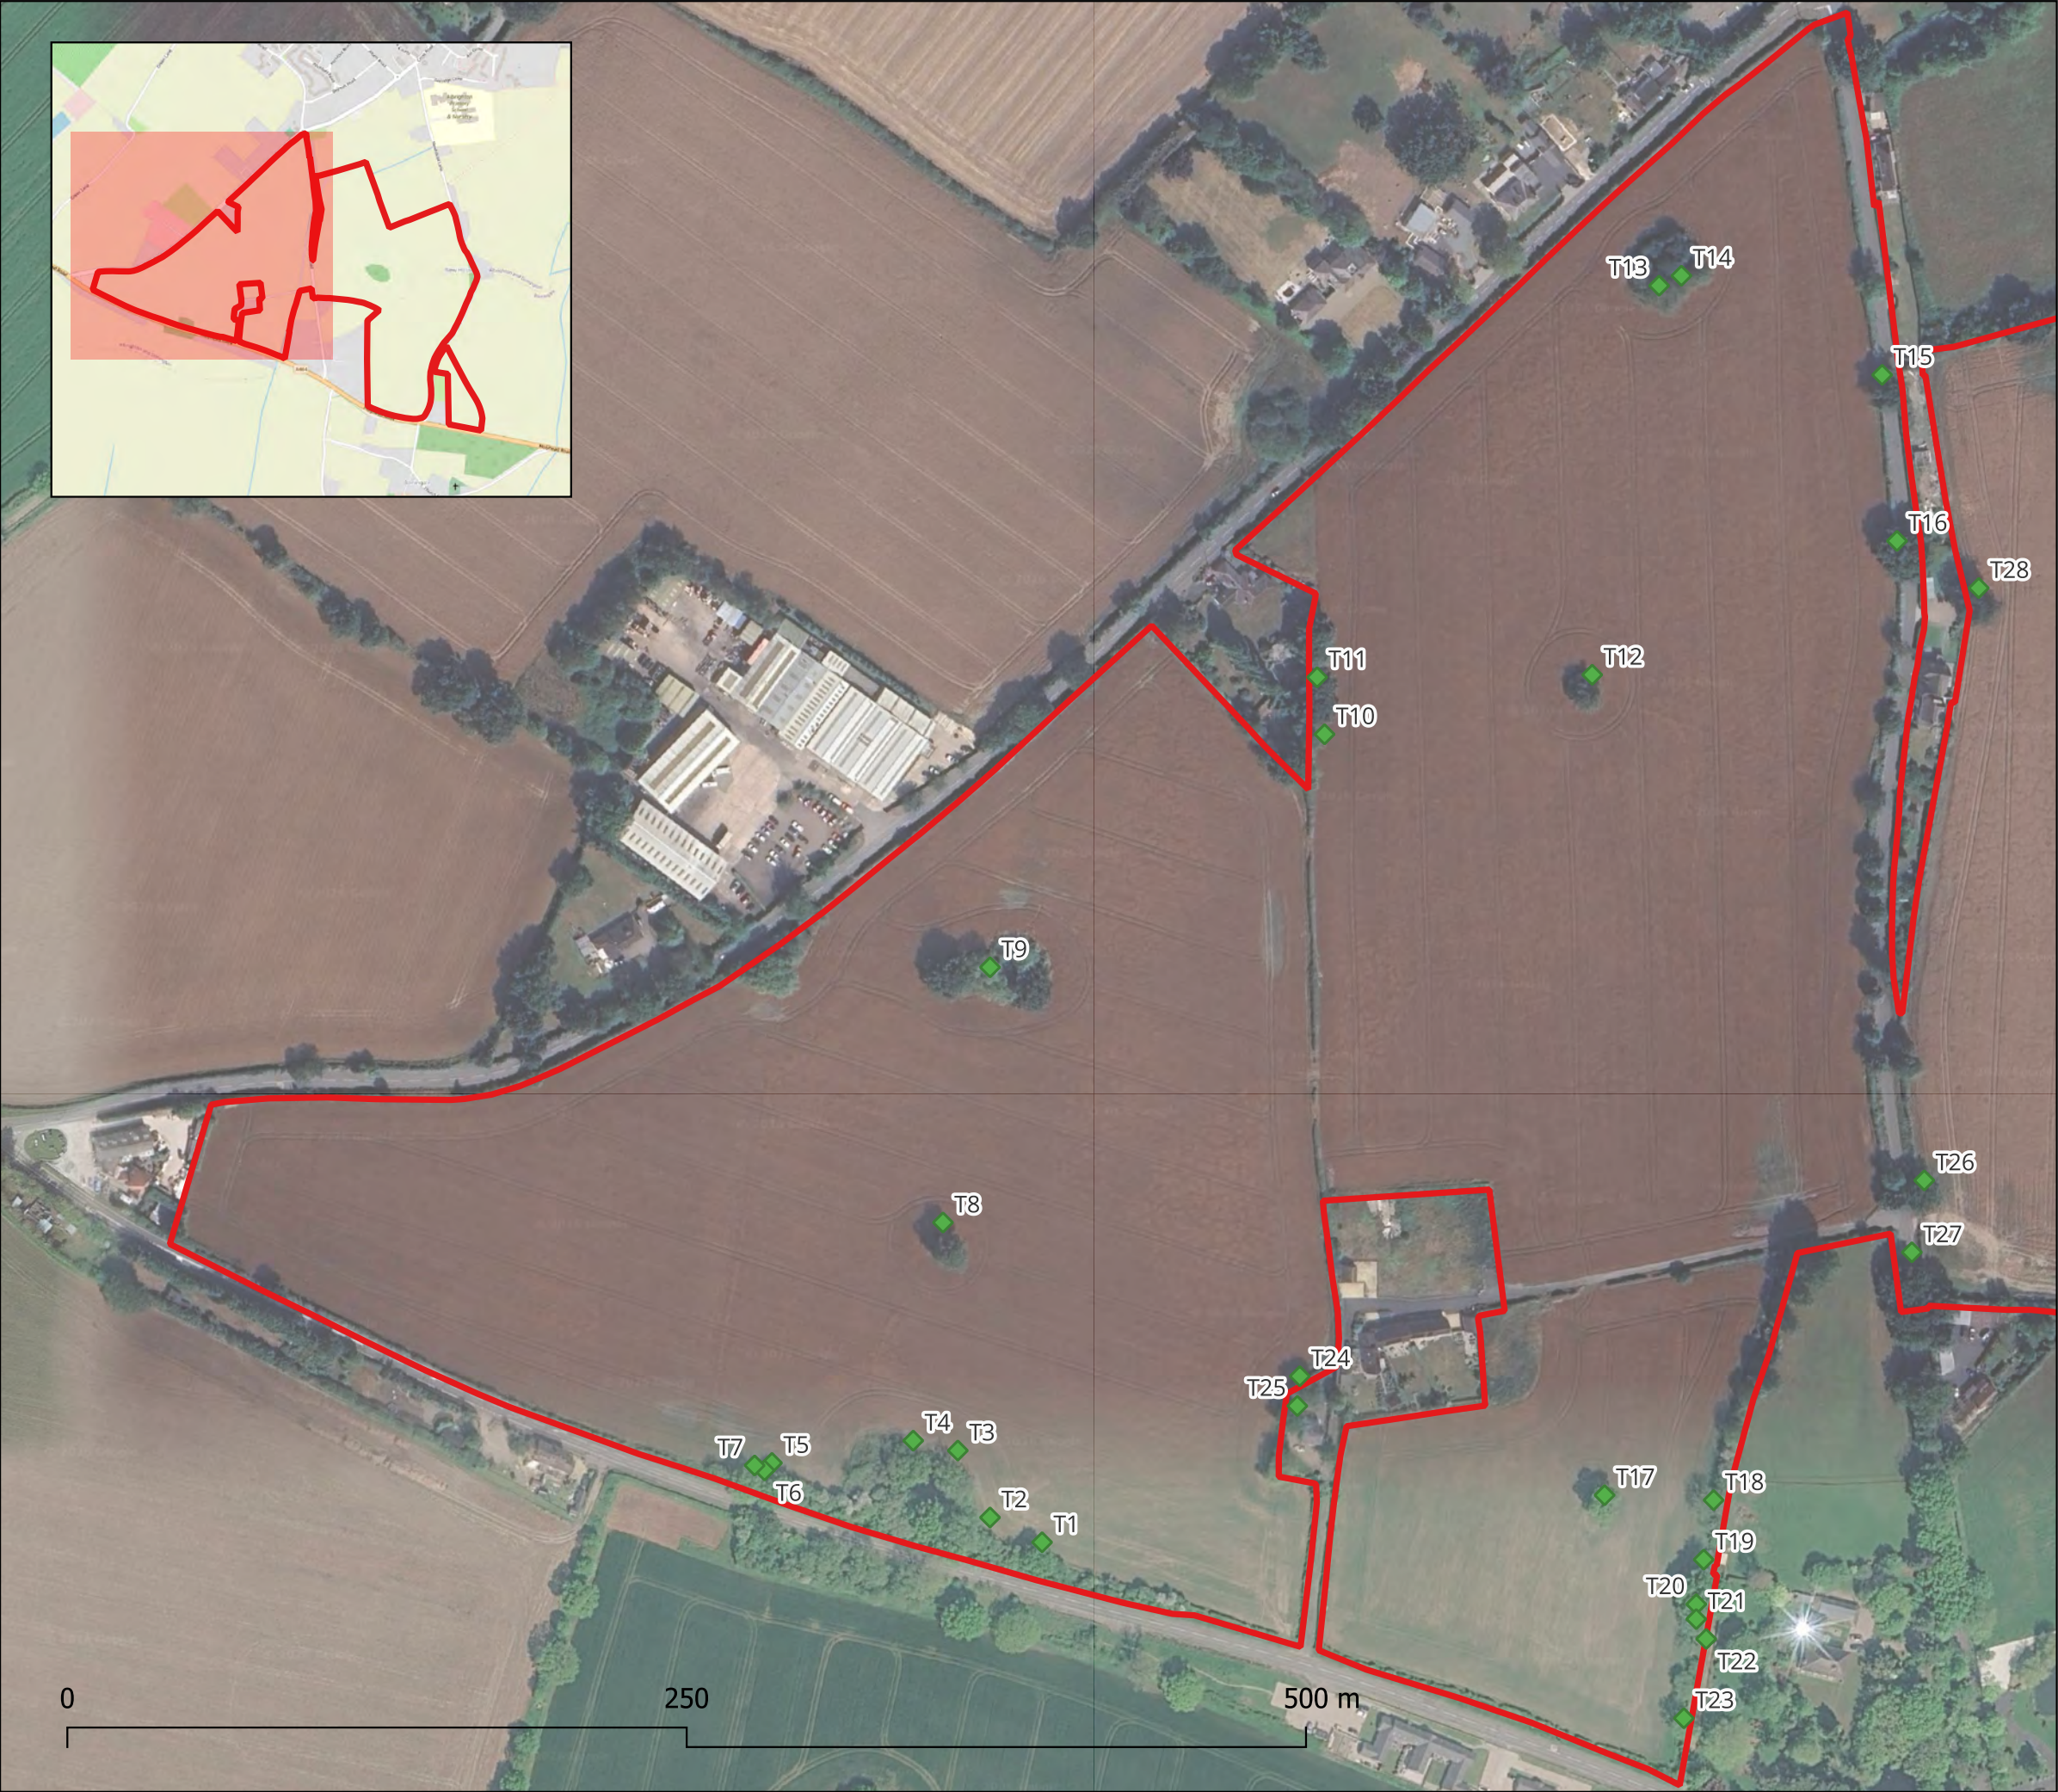
| DRAWING TITLE | | | Figure 2: Tree Locations 1/2 | | |

- 4.1 The original PJA GLTA identified 46 trees within the Site boundary supporting PRFs, comprising 25 provisionally classified as PRF-I and 21 as PRF-M. These findings were subsequently reviewed and verified by Beamsley Ecology Ltd as described in Section 2.0.
- 4.2 The results of the Ground Level Tree Assessment are presented in the table below. Tree references are shown on **Figure 2** and **Figure 3**. A detailed table of results is provided at **Appendix 1**.
