## Phase 1 Geotechnical & Geo-environmental Site Investigation

Albrighton South

Boningale Homes Limited

28 March 2024

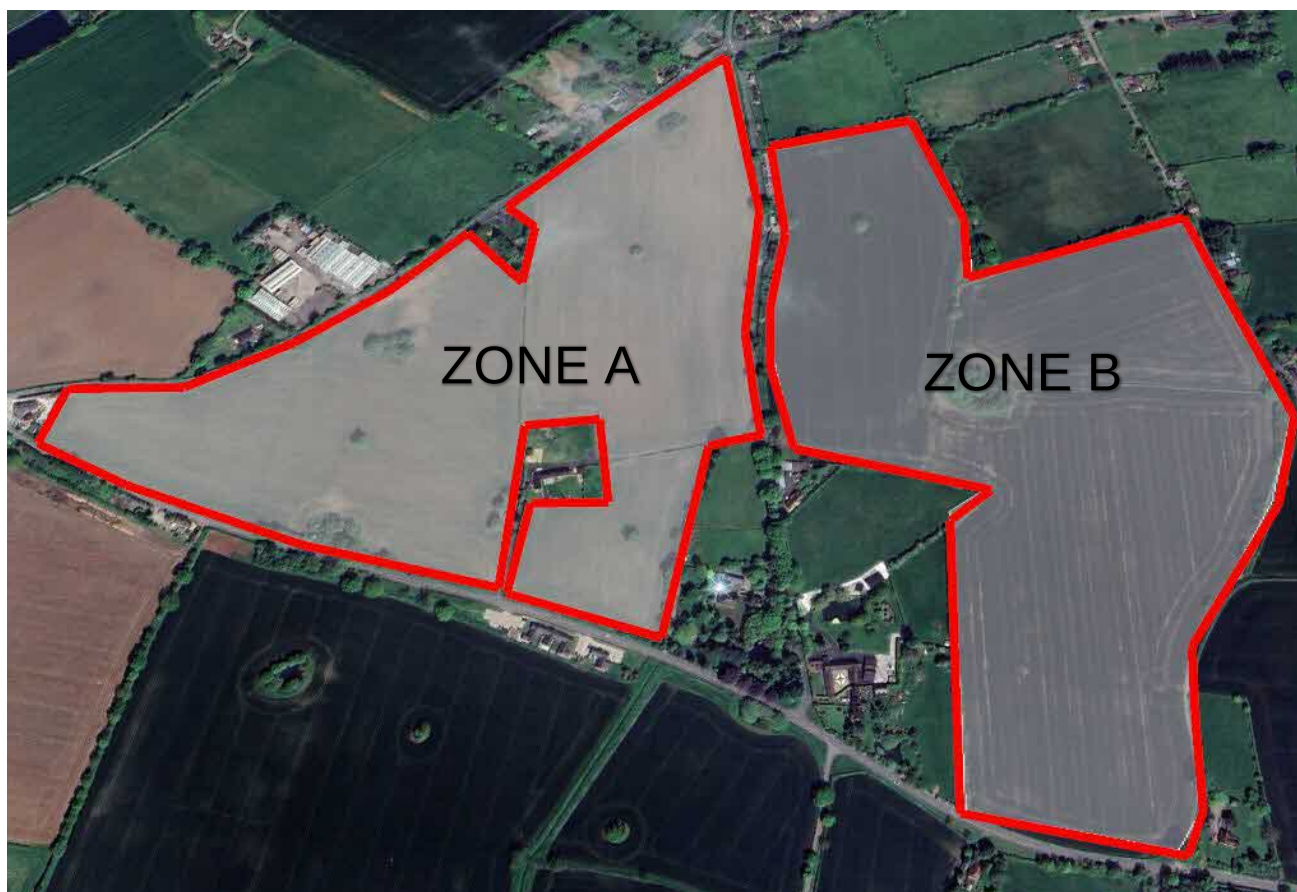
For the purpose of this report, the site has been separated into two areas, referenced as Zone A (west) and Zone B (east) as shown below:

Zone A comprises three arable agricultural fields, separated and bordered by hedgerows. Three ponds are present in this zone located on the north east corner, on the central southern boundary and on the central north of the zone. All of the ponds are surrounded by large mature trees, with sporadic isolated larger mature trees across the fields, and occasional large mature trees within the perimeter hedgerows. Surface water was also observed in isolated areas of this zone.

Zone B comprises two arable agricultural fields, separated and bordered by hedgerows with occasional areas of, and isolated, large mature trees. A pond is present on central north of this zone, surrounded by large mature trees. Surface water was also observed in isolated areas of this zone. A culvert is present to the south east of the pond, trending south east towards Newhouse Lane. Drainage ditches, with water present, are along the northern (~2.60 m wide and ~1.50 m deep) and eastern (~2.00 m wide by ~1.10 m deep) boundaries of the zone.
